PEST CONTROL EXPERTS

Facility Name & Address: IFF Fragrance Unit , srivity	Audited On: 09-04-2025
Audited By: SURESH KUMAR.V	
Client Contact Person Name: Mr. Siva (QC)	PC Experts Contact Person Name: SURESH KUMAR.V
Client Contact Person No: 7305428288	PC Experts Contact Person No: 8248672110

FACILITY SURROUNDING

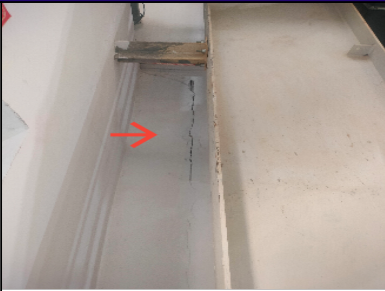
Internal Premises			REVIEW DATE	COMPLETION DATE
1

Location	Scrap material movement near emergency door top side	
		Cleaning / sanitation & Housekeeping Issues	Nil	
		Structural Issue (Pest harbourages)	Wall crack noticed	
		Access Issues	Nil	
		Description of Pest Infestation	It is Serious Threat for Ants, lizard and crawling insects hiding	
		Any other observations	Nil	
		Preventive Action suggested to customer	Cracks should be closed with cement or white cement	
		Curative action from	We are instructed to Technician for Regular Monitoring.

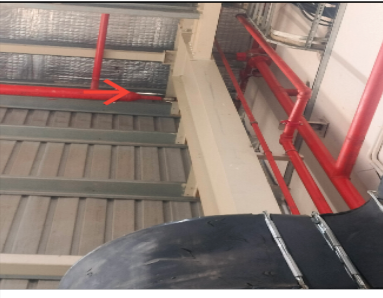
2

Location	Scrap movement area rooftop area		
		Cleaning / sanitation & Housekeeping Issues	Nil		
		Structural Issue (Pest harbourages)	Roof top gap observed		
		Access Issues	Nil		
		Description of Pest Infestation	It is Serious Threat for Beetles, lizards, crawling insects and ants		
		Any other observations	Nil		
		Preventive Action suggested to customer	Gap should be closed with rain proof sheet or form sealent		
		Curative action from	We are instructed to Technician for Regular Monitoring.		
3

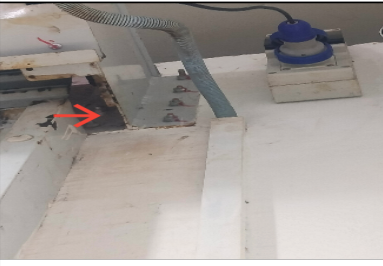
Location	Scrap movement area shutter		
		Cleaning / sanitation & Housekeeping Issues	Nil		
		Structural Issue (Pest harbourages)	Shutter top gap observed		
		Access Issues	Nil		
		Description of Pest Infestation	It is Serious Threat for Ants, lizard, beetles and other crawling insects		
		Any other observations	Nil		
		Preventive Action suggested to customer	Gap should be closed with rubber beading

Curative action from	We are instructed to Technician for Regular Monitoring.		
4

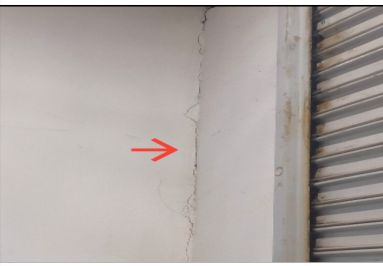
Location	Scrap movement area inside		
		Cleaning / sanitation & Housekeeping Issues	Nil		
		Structural Issue (Pest harbourages)	Wall crack observed		
		Access Issues	Nil		
		Description of Pest Infestation	It is Serious Threat for Ants, lizard, beetle May be hide		
		Any other observations	Nil		
		Preventive Action suggested to customer	Cracks and Crevices will be sealed with white cement or normal cement.		
		Curative action from	We are instructed to Technician for Regular Monitoring.

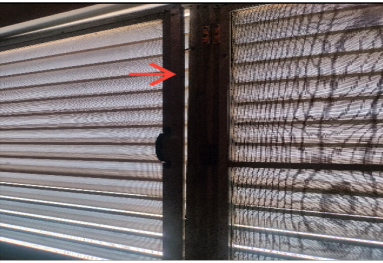
5

Location	FG storage area		
		Cleaning / sanitation & Housekeeping Issues	Nil		
		Structural Issue (Pest harbourages)	Windows mesh frame was opened condition		
		Access Issues	Nil		
		Description of Pest Infestation	It is Serious Threat for Ants, beetles, lizards, and crawling insects		
		Any other observations	Nil		
		Preventive Action suggested to customer	Mesh frame should be closed		
		Curative action from	We are instructed to Technician for Regular Monitoring.		
6

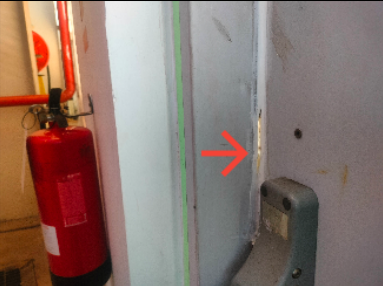
Location	FG storage area		
		Cleaning / sanitation & Housekeeping Issues	Nil		
		Structural Issue (Pest harbourages)	Door to door frame between gap noticed		
		Access Issues	Nil		
		Description of Pest Infestation	It is Serious Threat for Beetles, ants, lizards and other crawling insects		
		Any other observations	Nil		
		Preventive Action suggested to customer	Gap should be closed with rubber beading or silicone sealant		
		Curative action from	We are instructed to Technician for Regular Monitoring.

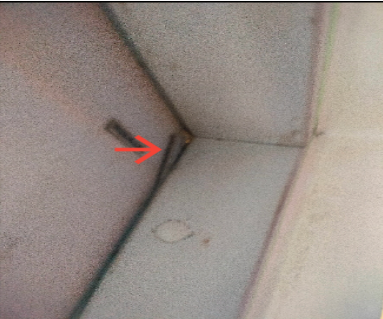
7

Location	FG storage area		
		Cleaning / sanitation & Housekeeping Issues	Nil		
		Structural Issue (Pest harbourages)	Rubber beading available but it's not fixed properly so that gap observed		
		Access Issues	Nil		
		Description of Pest Infestation	It is Serious Threat for Ants, lizards, beetles and other crawling insects		
		Any other observations	Nil		
		Preventive Action suggested to customer	Rubber beading should be placed properly without any gaps.		
		Curative action from	We are instructed to Technician for Regular Monitoring.

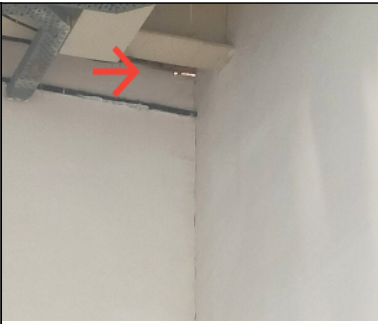
8

Location	FG office area near emergency door top roof area		
		Cleaning / sanitation & Housekeeping Issues	Nil		
		Structural Issue (Pest harbourages)	FG office behind emergency door top roof side area gap noticed		
		Access Issues	Nil		
		Description of Pest Infestation	It is Serious Threat for Beetle, ants, lizards and crawling insects		
		Any other observations	Nil		
		Preventive Action suggested to customer	Gap should be closed with rubber beading or form sealant		
		Curative action from	We are instructed to Technician for Regular Monitoring.		
9

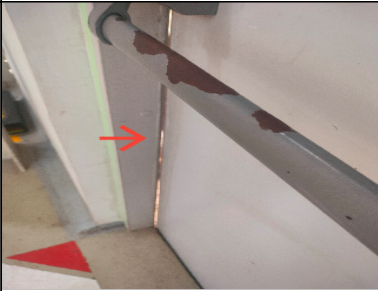
Location	RM office near emergency door		
		Cleaning / sanitation & Housekeeping Issues	Nil		
		Structural Issue (Pest harbourages)	Door to door frame between gap observed		
		Access Issues	Nil		
		Description of Pest Infestation	It is Serious Threat for Ants, beetles, lizards and other crawling insects		
		Any other observations	Nil		
		Preventive Action suggested to customer	Its should be closed with rubber beading or silicone sealant

Curative action from	We are instructed to Technician for Regular Monitoring.		
10

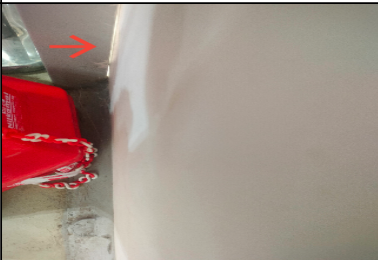
Location	FG unloading shutter area		
		Cleaning / sanitation & Housekeeping Issues	Nil		
		Structural Issue (Pest harbourages)	Wall to shutter frame gap noticed		
		Access Issues	Nil		
		Description of Pest Infestation	It is Serious Threat for Beetles, ants, lizards and other crawling insects		
		Any other observations	Nil		
		Preventive Action suggested to customer	It is should be closed with cement or silicone sealant.		
		Curative action from	We are instructed to Technician for Regular Monitoring.

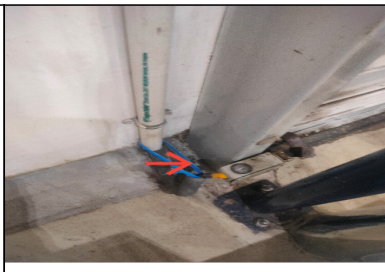
11

Location	RM loading area		
		Cleaning / sanitation & Housekeeping Issues	Nil		
		Structural Issue (Pest harbourages)	Shutter frame bottom to floor Gap observed		
		Access Issues	Nil		
		Description of Pest Infestation	It is Serious Threat for Ants, lizards, beetles and other crawling insects		
		Any other observations	Nil		
		Preventive Action suggested to customer	Gap should be closed with cement or rubber beading		
		Curative action from	We are instructed to Technician for Regular Monitoring.		
12

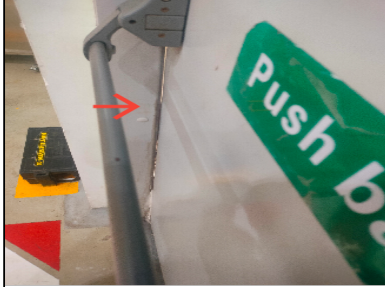
Location	Fg area to preparation area between emergency door		
		Cleaning / sanitation & Housekeeping Issues	Nil		
		Structural Issue (Pest harbourages)	Gap noticed from emergency door to frame		
		Access Issues	Nil		
		Description of Pest Infestation	It is Serious Threat for Ants, beetles and ants and other crawling insects		
		Any other observations	Nil		
		Preventive Action suggested to customer	Gap should be closed with rubber beading or silicone sealant

Curative action from	We are instructed to Technician for Regular Monitoring.		
External Premises				REVIEW DATE	COMPLETION DATE
13

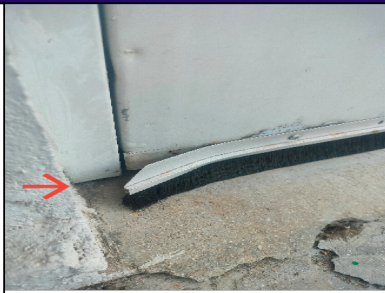
Location	FG outside behind scrap movement area right side emergency door.		
		Cleaning / sanitation & Housekeeping Issues	Nil		
		Structural Issue (Pest harbourages)	Door bottom sealed with brush but it is now Gap observed		
		Access Issues	Nil		
		Description of Pest Infestation	It is Serious Threat for Ants, crawling insects, beetles,		
		Any other observations	Nil		
		Preventive Action suggested to customer	Once again it should be closed with brush permanently		
		Curative action from	We are instructed to Technician for Regular Monitoring.

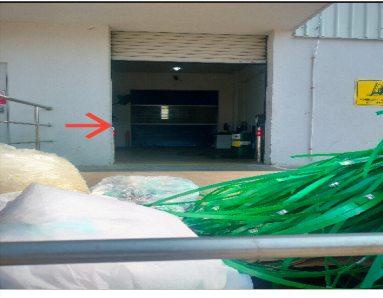
14

Location	Scrap movement area		
		Cleaning / sanitation & Housekeeping Issues	Nil		
		Structural Issue (Pest harbourages)	At the time of inspection shutter was opened condition.		
		Access Issues	Nil		
		Description of Pest Infestation	It is Serious Threat for Ants, snakes, lizards, crawling insects and rats may be get entry.		
		Any other observations	Nil		
		Preventive Action suggested to customer	Once work completed in that particular area, shutter should be closed.		
		Curative action from	We are instructed to Technician for Regular Monitoring.		
15

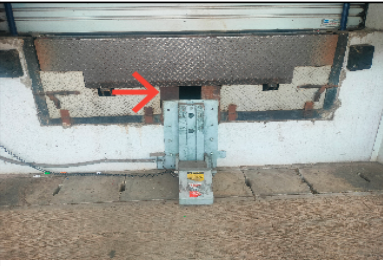
Location	Loading and unloading area		
		Cleaning / sanitation & Housekeeping Issues	Nil		
		Structural Issue (Pest harbourages)	Material lift area we observed the gaps		
		Access Issues	Nil		
		Description of Pest Infestation	It is Serious Threat for Ants, lizards, snakes, rodents and other crawling insects.		
		Any other observations	Nil

Preventive Action suggested to customer	It should be closed with rubber beading		
		Curative action from	We are instructed to Technician for Regular Monitoring.		
16

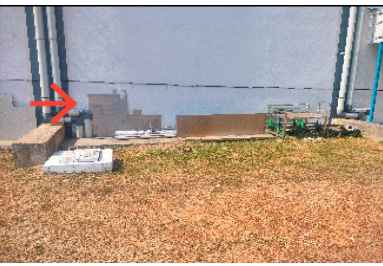
Location	Plant backside area		
		Cleaning / sanitation & Housekeeping Issues	Used materials kept on the Wall.		
		Structural Issue (Pest harbourages)	Nil		
		Access Issues	It is one of the pest hiding places.		
		Description of Pest Infestation	It is Serious Threat for Beetles, snakes rodents, lizards and other crawling insects		
		Any other observations	Nil		
		Preventive Action suggested to customer	Don't allow the material near or on the wallside.		
		Curative action from	We are instructed to Technician for Regular Monitoring.

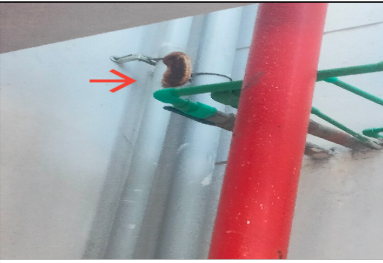
17

Location	Power panel room outside area.		
		Cleaning / sanitation & Housekeeping Issues	Dry Honey comb not removed		
		Structural Issue (Pest harbourages)	Nil		
		Access Issues	It is critical to the service because of height above 25 feet.		
		Description of Pest Infestation	It is Serious Threat for Ants, beetles, lizards		
		Any other observations	Nil		
		Preventive Action suggested to customer	Dry Honey comb should be removed		
		Curative action from	We are instructed to Technician for Regular Monitoring.		
18

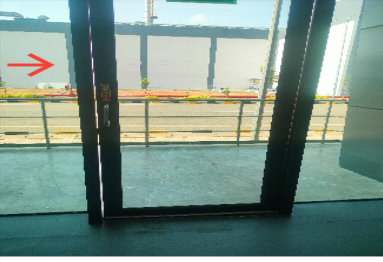
Location	Lab 1st floor area		
		Cleaning / sanitation & Housekeeping Issues	Nil		
		Structural Issue (Pest harbourages)	Some time door was opened condition		
		Access Issues	Nil		
		Description of Pest Infestation	It is Serious Threat for Ants,rats, snakes, pats, lizard and other crawling insects		
		Any other observations	Nil		
		Preventive Action suggested to customer	Whenever not used the doors, should be closed always

Curative action from	We are instructed to Technician for Regular Monitoring.		
19

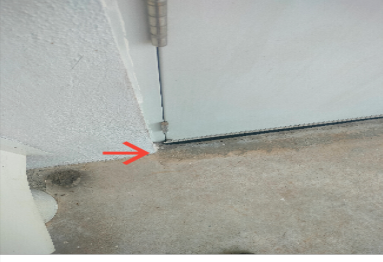
Location	Black side emergency door		
		Cleaning / sanitation & Housekeeping Issues	Nil		
		Structural Issue (Pest harbourages)	Emergency door bottom gap observed		
		Access Issues	Nil		
		Description of Pest Infestation	It is Serious Threat for Ants, beetles and lizards		
		Any other observations	Nil		
		Preventive Action suggested to customer	Gap should be closed with rubber beading or silicone sealant		
		Curative action from	We are instructed to Technician for Regular Monitoring.
