PEST CONTROL EXPERTS

Facility Name & Address: M/s. plastic omnium Auto Inergy Pvt Ltd , Lalapet, Ranipet	Audited On: 25-08-2025
Audited By: SURESH KUMAR.V	
Client Contact Person Name: Ms.Sudha (Asst HR)	PC Experts Contact Person Name: SURESH KUMAR.V
Client Contact Person No: 9655249232	PC Experts Contact Person No: 8248672110

FACILITY SURROUNDING

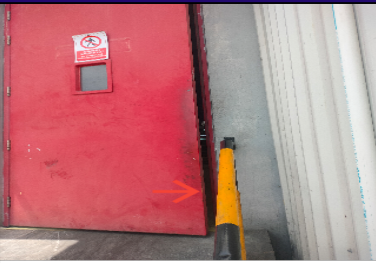
1

Location	Main buliding back side (emergency door)		
	Cleaning / sanitation & Housekeeping Issues	Nil		
	Structural Issue (Pest harbourages)	Door was opened condition		
	Access Issues	Nil		
	Description of Pest Infestation	It is Serious Threat for Rodent, lizards, snakes and other crawling insects		
	Any other observations	Nil		
	Preventive Action suggested to customer	All doors should be closed without any gaps		
	Curative action from	We are instructed to Technician for Regular Monitoring.

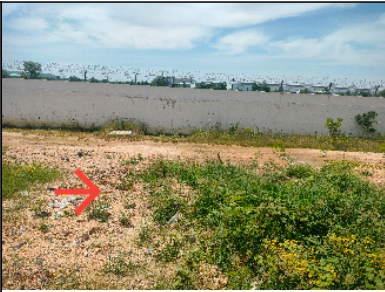
Location	Back side compound wall area		
		Cleaning / sanitation & Housekeeping Issues	Thick vegetation observed		
		Structural Issue (Pest harbourages)	Compound wall having Holes		
		Access Issues	Nil		
		Description of Pest Infestation	It is Serious Threat for snakes, rodent and other crawling insects		
		Any other observations	Nil		
		Preventive Action suggested to customer	Holes should be closed with cement. Vegetation should be clean on regular basis.		
		Curative action from	We are instructed to Technician for Regular Monitoring.		
2

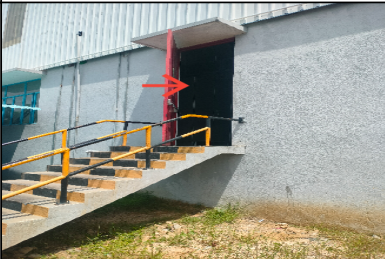
Location	Main buliding back side (Emergency exit door)		
		Cleaning / sanitation & Housekeeping Issues	Nil		
		Structural Issue (Pest harbourages)	Door was Opened Condition		
		Access Issues	Nil		
		Description of Pest Infestation	It is Serious Threat for Monkey, snakes, Rodents and other crawling insects		
		Any other observations	Nil		
		Preventive Action suggested to customer	Door should be closed without any gaps

Curative action from	We are instructed to Technician for Regular Monitoring.		
3

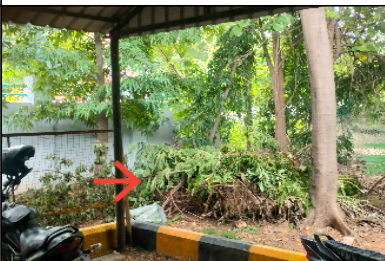
4

Location	Two wheeler parking area		
		Cleaning / sanitation & Housekeeping Issues	Lot Thick vegetation observed		
		Structural Issue (Pest harbourages)	Nil		
		Access Issues	Nil		
		Description of Pest Infestation	It is Serious Threat for Ants, mosquitos, lizards, snakes, rodent and other crawling insects		
		Any other observations	Nil		
		Preventive Action suggested to customer	Thick vegetation should be clean on regular basis		
		Curative action from	We are instructed to Technician for Regular Monitoring.

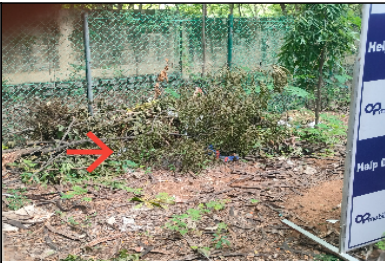
Location	Parking area		
		Cleaning / sanitation & Housekeeping Issues	Thick vegetation observed		
		Structural Issue (Pest harbourages)	Nil		
		Access Issues	Nil		
		Description of Pest Infestation	It is Serious Threat for Beetles, ants, mosquitos, rodent, snakes and other crawling insects.		
		Any other observations	Nil		
		Preventive Action suggested to customer	Thick vegetation should be clean on regular basis		
		Curative action from	We are instructed to Technician for Regular Monitoring.		
5

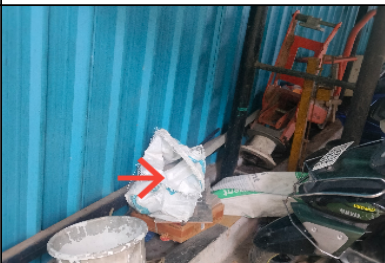
Location	Two wheeler parking area (near godown)		
		Cleaning / sanitation & Housekeeping Issues	Un used materials kept near by godown		
		Structural Issue (Pest harbourages)	Nil		
		Access Issues	Nil		
		Description of Pest Infestation	It is Serious Threat for snakes, Rodent and other crawling insects		
		Any other observations	Nil		
6

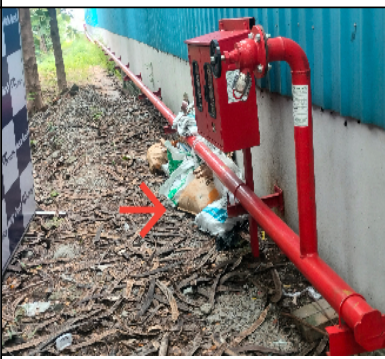
7

Location	Godown back side		
		Cleaning / sanitation & Housekeeping Issues	Unused material kept near by building and Thick vegetation observed

Structural Issue (Pest harbourages)	Old godown wall to wall metal sheet having gaps.		
		Access Issues	Nil		
		Description of Pest Infestation	It is Serious Threat for Beetles, mosquitos, snakes, rodents and other crawling insects		
		Any other observations	Nil		
		Preventive Action suggested to customer	Gap should be closed with cement or foam sealent. Don't allow the materials near by the building out side. Thick vegetation should be clean on regular basis.		
		Curative action from	We are instructed to Technician for Regular Monitoring.

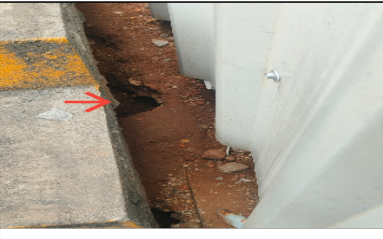
Location	Main buliding back side (steps area under)		
		Cleaning / sanitation & Housekeeping Issues	We observed the rodent borrows		
		Structural Issue (Pest harbourages)	Nil		
		Access Issues	Nil		
		Description of Pest Infestation	It is Serious Threat for rodent and snakes		
		Any other observations	Nil		
		Preventive Action suggested to customer	Steps under borrows should closed with cement		
		Curative action from	We are instructed to Technician for Regular Monitoring.		
8

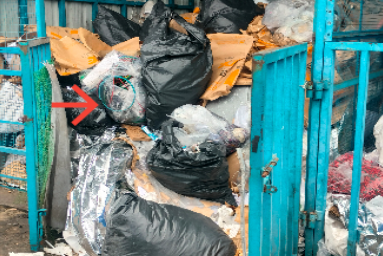
Location	Waste dumping area		
		Cleaning / sanitation & Housekeeping Issues	Waste should be clean on regular basis		
		Structural Issue (Pest harbourages)	Waste dumping area was opened condition		
		Access Issues	Nil		
		Description of Pest Infestation	It is Serious Threat for rodent, snakes and other crawling insects		
		Any other observations	Nil		
		Preventive Action suggested to customer	Waste should be clean on regular basis.

Curative action from	We are instructed to Technician for Regular Monitoring.		
9

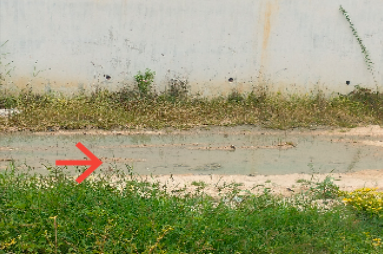
11

Location	Back side compound wall area		
		Cleaning / sanitation & Housekeeping Issues	Lot of water stagnated		
		Structural Issue (Pest harbourages)	Nil		
		Access Issues	Nil		
		Description of Pest Infestation	It is Serious Threat for mosquitos, other crawling insects		
		Any other observations	Nil		
		Preventive Action suggested to customer	Don't allow the stagnating water in factory premises

Curative action from	We are instructed to Technician for Regular Monitoring.

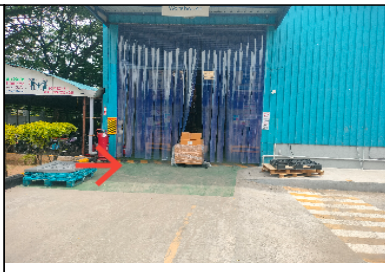
Location	Ware House (Entrance area)		
		Cleaning / sanitation & Housekeeping Issues	Nil		
		Structural Issue (Pest harbourages)	Main entrance was opened condition		
		Access Issues	Nil		
		Description of Pest Infestation	It is Serious Threat for snakes, rodents and other crawling insects		
		Any other observations	Nil		
		Preventive Action suggested to customer	Shutters should be closed condition		
		Curative action from	We are instructed to Technician for Regular Monitoring.		
12

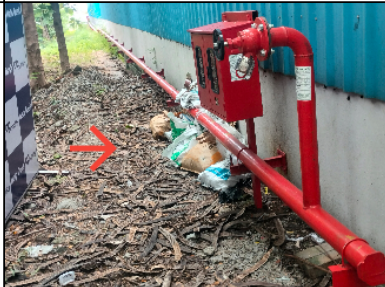
Location	Ware House back side		
		Cleaning / sanitation & Housekeeping Issues	Nil		
		Structural Issue (Pest harbourages)	Ware House Back side floor concrete not available		
		Access Issues	Nil		
		Description of Pest Infestation	It is Serious Threat for mosquitos, rodent, snakes other crawling insects		
		Any other observations	Nil		
		Preventive Action suggested to customer	Ware House back side floor concrete should be placed upto 2 feet

Curative action from	We are instructed to Technician for Regular Monitoring.		
Note: In General your all window mesh will be replaced all windows. Also in Processing area. Fly Killer Machine will be placed to Fly Catcher Machines					
For Pest Control Experts			For M/s. M/s. plastic omnium Auto Inergy Pvt Ltd ,		
Authorized Signature.			Authorized Signature.		
Name: SURESH KUMAR.V			Name:		
Designation: MANAGER			Designation:		
Emp.Code: 002			Emp.Code:		
Phone Number: 8248672110			Phone Number:
