PEST CONTROL EXPERTS

| Facility Name & Address: Levture wellness pvt ltd , Chittoor | Audited On: 30-05-2025 |

FACILITY SURROUNDING

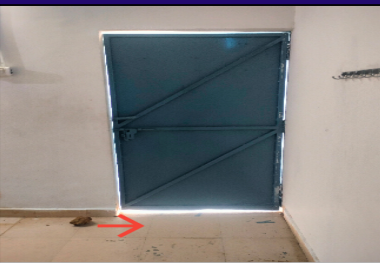
| Internal Premises | | | | REVIEW DATE | COMPLETION DATE |
|---|--|---|---|---|---|
| 1 | | Location | Hygiene Entry area | | |

| Internal Premises | | | | REVIEW DATE | COMPLETION DATE |
|---|--|---|---|---|---|
| | | Structural Issue (Pest harbourages) | Door surrounding gap observed | | |
| | | Description of Pest Infestation | It is Serious Threat for Ants, lizards, snakes, rat, flies and other crawling insects | | |

| Internal Premises | | | | REVIEW DATE | COMPLETION DATE |
|---|--|---|---|---|---|
| | | Preventive Action suggested to customer | It's should be closed with rubber beading | | |

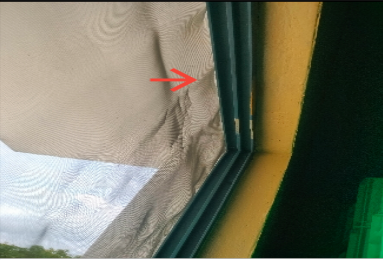
| 3 | | Location | Fruit packing area | | |

| | | Structural Issue (Pest harbourages) | Mesh to mesh frame gap observed | | |
| | | Description of Pest Infestation | It is Serious Threat for Ants, lizards, flies & other crawling insects | | |

| | | Preventive Action suggested to customer | Gap should be closed with mesh | | |

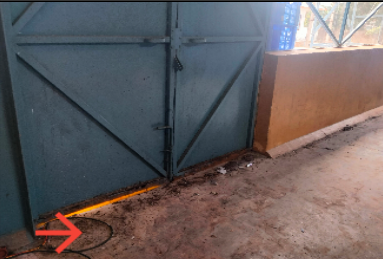
| 5 | | Location | Fruit receiving area | | |

| | | Structural Issue (Pest harbourages) | Door bottom gap observed | | |
| | | Description of Pest Infestation | It is Serious Threat for Ants, bettle, lizards, flies and other crawling insects | | |

| | | Preventive Action suggested to customer | Gap should be closed with rubber beading | | |

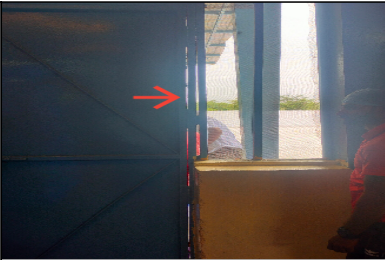
| 6 | | Location | Fruit receiving area | | |

| | | Structural Issue (Pest harbourages) | Gap observed between the door frame to door frame | | |
| | | Description of Pest Infestation | It is Serious Threat for Ants, lizards, flies and other crawling | | |

| | | Preventive Action suggested to customer | Gap should be closed with form sealent | | |

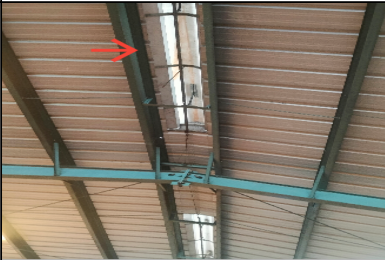
| 9 | | Location | Fruit receiving area | | |

| | | Structural Issue (Pest harbourages) | Roof top air exhaust purpose structure was placed,in that place gap observed | | |
| | | Description of Pest Infestation | It is Serious Threat for Beetles, lizards, flies, Bird | | |

| | | Preventive Action suggested to customer | That should be closed with mesh | | |

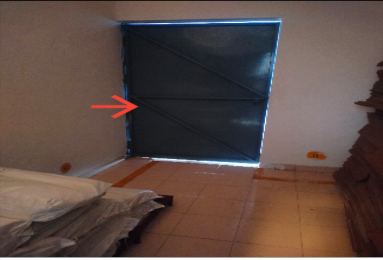
| | | Location | Store room | | |

| | | Structural Issue (Pest harbourages) | Door to door frame gap observed | | |
| | | Description of Pest Infestation | It is Serious Threat for Ants, snake, lizards, flies and other crawling insects | | |

| | | Preventive Action suggested to customer | Gap should be closed with rubber beading | | |

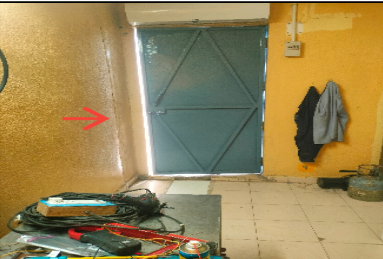
| | | Location | Maintenance room | | |

| 12 | | Structural Issue (Pest harbourages) | Gap observed between the door to door frame | | |
| | | Description of Pest Infestation | It is Serious Threat for flies,Ants, beetles, lizards, rat and other crawling insects | | |

| | | Preventive Action suggested to customer | Gap should be closed with rubber beading | | |

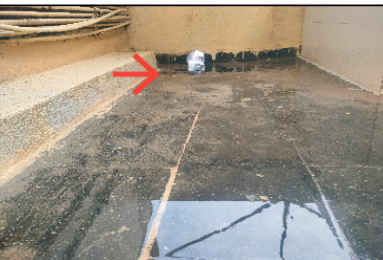
| | | Location | Crate washing area | | |

| | | Structural Issue (Pest harbourages) | Water running hole observed | | |
| | | Description of Pest Infestation | It is Serious Threat for rats, ants, lizards, snakes and other crawling insects | | |

| | | Preventive Action suggested to customer | Pipe hole should be closed with mesh | | |

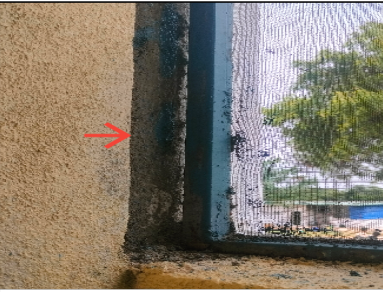
| 14 | | Location | Crate washing area | | |

| | | Structural Issue (Pest harbourages) | Wall to mesh frame gap observed | | |
| | | Description of Pest Infestation | It is Serious Threat for Beetles, ants, lizards, flies and other crawling insects | | |

| | | Preventive Action suggested to customer | Gap should be closed with cement or rubber beading or form sealant | | |

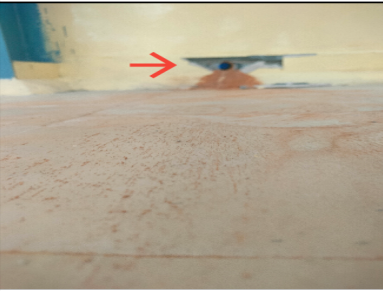
| 15 | | Location | Fruit packing area | | |

| | | Structural Issue (Pest harbourages) | Hole observed | | |
| | | Description of Pest Infestation | It is Serious Threat for Ants, lizards, rat and other crawling insects | | |

| | | Preventive Action suggested to customer | Hole should be closed or what purpose made that should implement | | |

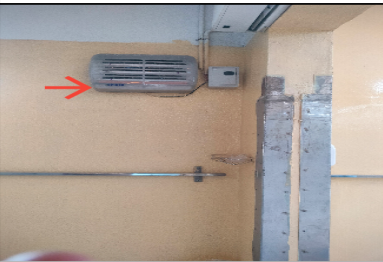
| 16 | | Location | Fruit packing area | | |

| | | Access Issues | Machine switched off condition | | |
| | | Description of Pest Infestation | It is Serious Threat for beetles, flies and other crawling insects | | |

| | | Preventive Action suggested to customer | Machine should be working condition | | |

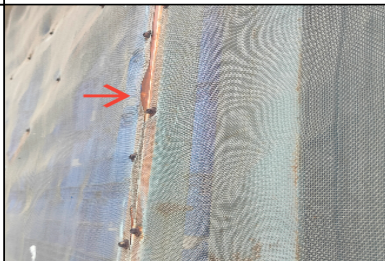
| External Premises | | | | REVIEW DATE | COMPLETION DATE |
|--|--|---|--|---|---|
| 18 | | Location | Fruit receiving area | | |

| External Premises | | | | REVIEW DATE | COMPLETION DATE |
|--|--|---|--|---|---|
| | | Structural Issue (Pest harbourages) | Mesh to frame gap observed | | |
| | | Description of Pest Infestation | It is Serious Threat for flies, lizards and other crawling insects | | |

| External Premises | | | | REVIEW DATE | COMPLETION DATE |
|--|--|---|--|---|---|
| | | Preventive Action suggested to customer | Gap should be closed with mesh | | |
