PEST CONTROL EXPERTS

| Facility Name & Address: M/s. LCN Industries, Chittoor | Audited On: 15-09-2025 |

FACILITY SURROUNDING

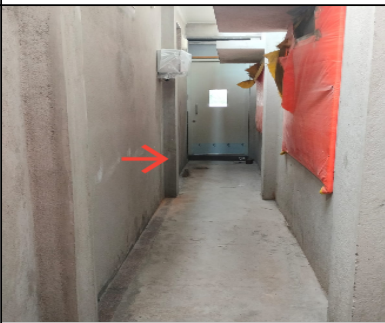
| 5 | | Location | Back side emergency door area. | | |

| | | Structural Issue (Pest harbourages) | Emergency door surrounding lot of gaps observed | | |
| | | Description of Pest Infestation | It is Serious Threat for Ants, lizards, Cockroaches, flying insects and other crawling insect | | |
| | | Any other observations | Near cable switch box and wall between holes observed | | |

| | | Preventive Action suggested to customer | Gap should be closed with cement or form sealent. Cable hole should be closed with form or silicone sealent. | | |

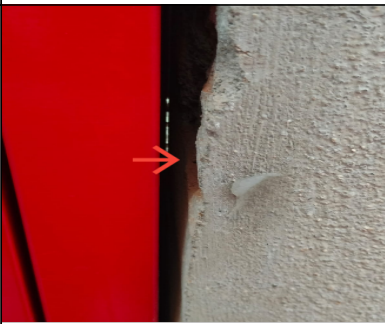
| 6 | | Location | Main emergency door (outside) | | |

| | | Structural Issue (Pest harbourages) | Emergency door frame surrounding gaps noticed | | |
| | | Description of Pest Infestation | It is Serious Threat for Ants, beetles, lizards, flying insects and other crawling insect | | |
| | | Any other observations | Emergency Door bottom gap observed. | | |

| | | Preventive Action suggested to customer | Frame surroundings gap should be closed with cement or form sealent. Door bottom gap should be closed with rubber beading. | | |

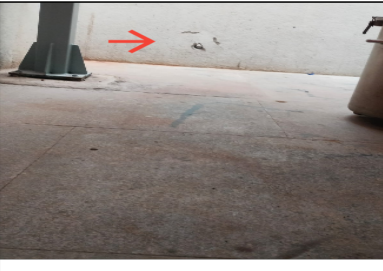
| 7 | | Location | Main building outer area | | |

| | | Structural Issue (Pest harbourages) | Wall having hole, that we observed | | |
| | | Description of Pest Infestation | It is Serious Threat for Beetles, Ants, rodent, lizards, snake and other crawling insect | | |

| | | Preventive Action suggested to customer | Hole should be closed with cement | | |

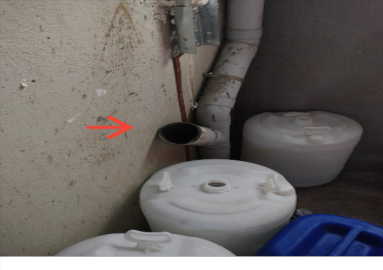
| 8 | | Location | Vessels washing back side. | | |

| | | Structural Issue (Pest harbourages) | Pipe was opened condition | | |
| | | Description of Pest Infestation | It is Serious Threat for Ants, Beetles, flying insects, lizards, cockroaches and other crawling insect | | |

| | | Preventive Action suggested to customer | Pipe should be closed with lid or pipe cap | | |

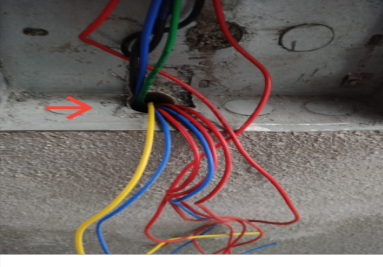
| 9 | | Location | Main building outer (emergency door near) | | |

| | | Structural Issue (Pest harbourages) | Cable line was opened conditions | | |
| | | Description of Pest Infestation | It is Serious Threat for Ants, beetles, lizards and other crawling insect | | |

| | | Preventive Action suggested to customer | Switch box should be placed without any gaps | | |

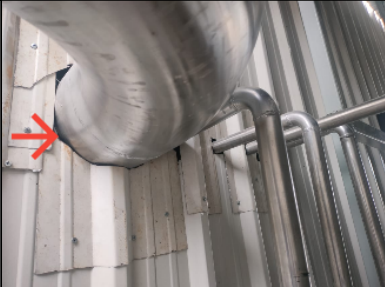
| 12 | | Location | Main building outer area (outer AHU area) | | |

| | | Structural Issue (Pest harbourages) | Pipe surrounding gaps observed. All SS pipes surrounding holes observed | | |
| | | Description of Pest Infestation | It is Serious Threat for Ants, spider, lizards, beetles, flying insects and other crawling insect. | | |

| | | Preventive Action suggested to customer | All pipe holes should be closed with form sealent | | |

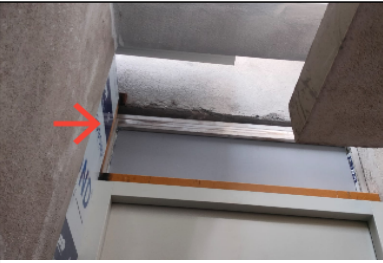
| 13 | | Location | Main building emergency door area. | | |

| | | Structural Issue (Pest harbourages) | Door top left corner we observed the gaps. | | |
| | | Description of Pest Infestation | It is Serious Threat for Ants, beetles,lizards, flying insects and other crawling insect | | |

| | | Preventive Action suggested to customer | Gap should be closed with sheets without any gaps. | | |

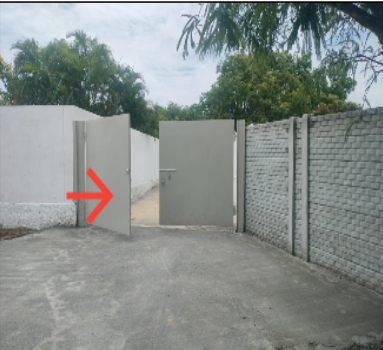
| 16 | | Location | Main gate area | | |

| | | Structural Issue (Pest harbourages) | Main gate bottom gaps noticed and gate to gate stem between gap observed. | | |
| | | Description of Pest Infestation | It is Serious Threat for Beetles, rodent, lizards, snake and other crawling insect. | | |

| | | Preventive Action suggested to customer | Door bottom metal sheet or rubber beading should be placed. Stem to gate between gap should be closed with rubber beading. | | |
