PEST CONTROL EXPERTS

Facility Name & Address: M/s. LCN Industries, Chittoor	Audited On: 15-09-2025
Audited By: SURESH KUMAR.V	
Client Contact Person Name: Mr. Pandiyan (Manager)	PC Experts Contact Person Name: SURESH KUMAR.V
Client Contact Person No: 9493173163	PC Experts Contact Person No: 8248672110

FACILITY SURROUNDING

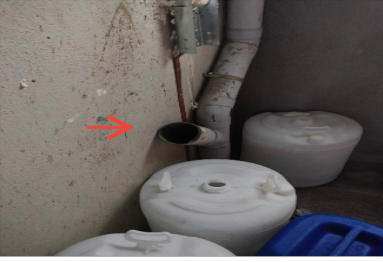
Location	Main building outer area		
		Cleaning / sanitation & Housekeeping Issues	Nil		
		Structural Issue (Pest harbourages)	Wall having hole, that we observed		
		Access Issues	Nil		
		Description of Pest Infestation	It is Serious Threat for Beetles, Ants, rodent, lizards, snake and other crawling insect		
		Any other observations	Nil		
		Preventive Action suggested to customer	Hole should be closed with cement		
		Curative action from	We are instructed to Technician for Regular Monitoring.		
8
