Facility Name & Address: SRI VARSHA INTEGRATED FOOD PARK PVT LTD , Kadapa	Audited On: 02-05-2025
Disrupted By: SURESH KUMAR.V	
Client Contact Person Name: Mr. Andha krishnan (QC)	PC Experts Contact Person Name: SURESH KUMAR.V
Client Contact Person No: 9994353712	PC Experts Contact Person No: 8248672110

FACILITY SURROUNDING

Internal Premises			REVIEW DATE	COMPLETION DATE
1

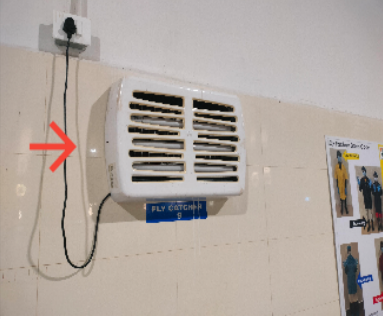
Location	Processing hall inside	
		Cleaning / sanitation & Housekeeping Issues	Nil	
		Structural Issue (Pest harbourages)	Nil	
		Access Issues	At the time of inspection Fly catcher machine all are switched off condition.	
		Description of Pest Infestation	It is Serious Threat for Flying insects	
		Any other observations	Nil	
		Preventive Action suggested to customer	Fly Catcher machine should be worked and some of the machines lights are burning is not upto level that has to be changed.	
		Curative action from	We are instructed to Technician for Regular Monitoring.

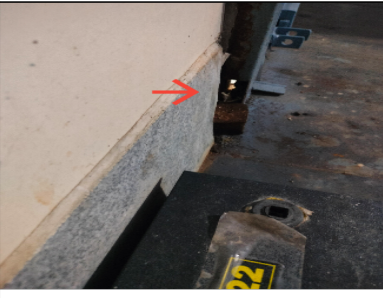
2

Location	Processing hall main shutter		
		Cleaning / sanitation & Housekeeping Issues	Nil		
		Structural Issue (Pest harbourages)	Shutter frame both side we observed gaps		
		Access Issues	Nil		
		Description of Pest Infestation	It is Serious Threat for Beetles, ants, rats, snakes, lizards and other crawling insects.		
		Any other observations	Nil		
		Preventive Action suggested to customer	Gap should be closed with rubber beading or metal sheet or cement concrete		
		Curative action from	We are instructed to Technician for Regular Monitoring.		
3

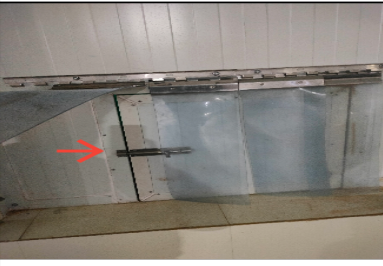
Location	Processing hall mini size door area		
		Cleaning / sanitation & Housekeeping Issues	Nil		
		Structural Issue (Pest harbourages)	Door to door frame Gap observed		
		Access Issues	Nil		
		Description of Pest Infestation	It is Serious Threat for Ants, Flying insects, small lizards and other crawling insects		
		Any other observations	Nil		
		Preventive Action suggested to customer	Gap should be closed with rubber beading

Curative action from	We are instructed to Technician for Regular Monitoring.		
4

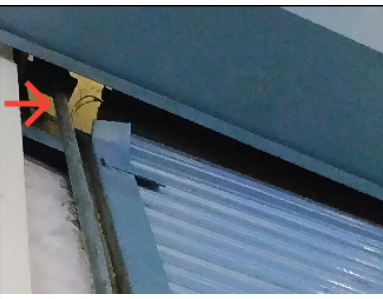
Location	Processing hall main shutter		
		Cleaning / sanitation & Housekeeping Issues	Nil		
		Structural Issue (Pest harbourages)	Shutter top side we observed gaps		
		Access Issues	Nil		
		Description of Pest Infestation	It is Serious Threat for Ants, spiders, lizards, flying insects, beetles and other crawling insects		
		Any other observations	Nil		
		Preventive Action suggested to customer	Gap should be closed with pvc sheets or metal sheet without any gaps.		
		Curative action from	We are instructed to Technician for Regular Monitoring.

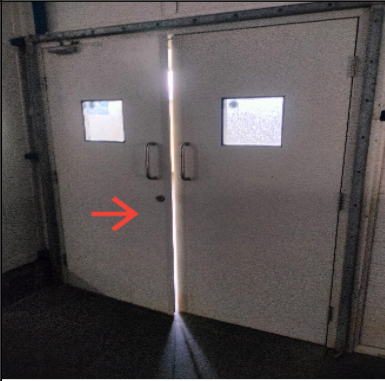
5

Location	Fruit feeding to processing doors area		
		Cleaning / sanitation & Housekeeping Issues	Nil		
		Structural Issue (Pest harbourages)	At the time inspection doors not closed properly and gap noticed		
		Access Issues	At the time of inspection Air curtains switched off conditions.		
		Description of Pest Infestation	It is Serious Threat for Ants, flying insects, beetles, lizards, spiders and other crawling insects		
		Any other observations	Nil		
		Preventive Action suggested to customer	Doors should be closed without any gap. Air curtains should be working condition and air curtains air velocity to be checked		
		Curative action from	We are instructed to Technician for Regular Monitoring.		
6

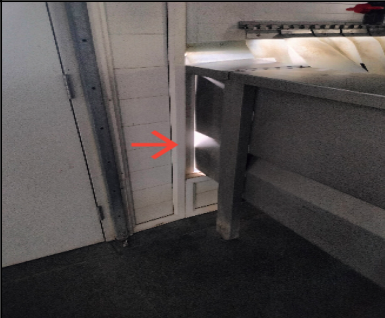
Location	Fruit feeding area		
		Cleaning / sanitation & Housekeeping Issues	Nil		
		Structural Issue (Pest harbourages)	Fruit feeding container to puffed panel frame Gap noticed		
		Access Issues	Nil

Description of Pest Infestation	It is Serious Threat for Beetles, flying insects, lizards, Ants snakes and other crawling insects		
		Any other observations	Nil		
		Preventive Action suggested to customer	Gap should be closed with foam sealant or proper size metal sheet without any gaps.		
		Curative action from	We are instructed to Technician for Regular Monitoring.		
7

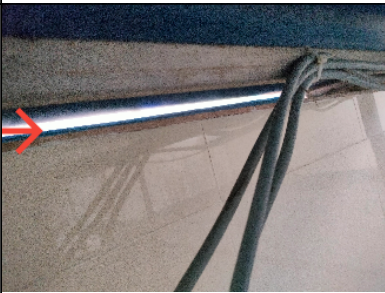
Location	Fruit feeding area		
		Cleaning / sanitation & Housekeeping Issues	Nil		
		Structural Issue (Pest harbourages)	Fruit feeding conveyor bottom gap observed		
		Access Issues	Nil		
		Description of Pest Infestation	It is Serious Threat for flying insects, lizards, ants beetles and other crawling insects		
		Any other observations	Nil		
		Preventive Action suggested to customer	Gap should be closed with rubber beading or suitable materials without any gaps.		
		Curative action from	We are instructed to Technician for Regular Monitoring.

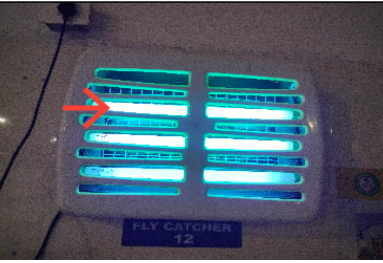
8

Location	Hygiene entrance area		
		Cleaning / sanitation & Housekeeping Issues	Nil		
		Structural Issue (Pest harbourages)	Nil		
		Access Issues	UV lights illumination not upto the level		
		Description of Pest Infestation	It is Serious Threat for flying insects and beetles		
		Any other observations	Nil		
		Preventive Action suggested to customer	Lights should be replaced. In food industry mostly recommended the sleeved UV lights as per glass policy.		
		Curative action from	We are instructed to Technician for Regular Monitoring.		
9

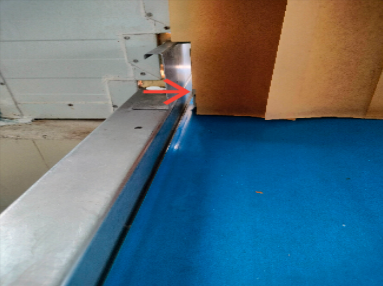
Location	Fruit feeding conveyor		
		Cleaning / sanitation & Housekeeping Issues	Nil		
		Structural Issue (Pest harbourages)	Fruit feeding conveyor line we observed gaps		
		Access Issues	Nil		
		Description of Pest Infestation	It is Serious Threat for Ants, flying insects, lizards, beetles, rat and other crawling insects.		
		Any other observations	Nil		
		Preventive Action suggested to customer	Gap should be closed with metal sheet or rubber beading without any gaps.

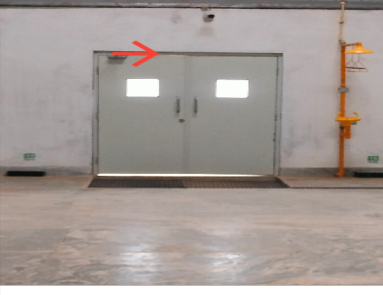
10

Curative action from	We are instructed to Technician for Regular Monitoring.		
		Location	Store room near emergency door		
		Cleaning / sanitation & Housekeeping Issues	Nil		
		Structural Issue (Pest harbourages)	Bottom of the doors and top side we observed gaps.		
		Access Issues	Nil		
		Description of Pest Infestation	It is Serious Threat for Ants, snake, lizards, flying insects, beetles and other crawling insects.		
		Any other observations	Nil		
		Preventive Action suggested to customer	Gap should be closed with rubber beading top and bottom side.		
		Curative action from	We are instructed to Technician for Regular Monitoring.

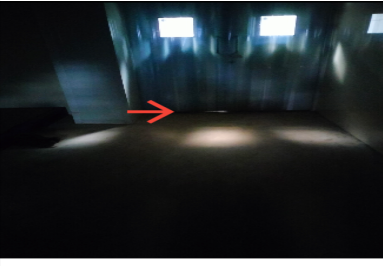
Location	Packing material store room		
		Cleaning / sanitation & Housekeeping Issues	Nil		
		Structural Issue (Pest harbourages)	Packing material store doors bottom gap observed.		
		Access Issues	Nil		
		Description of Pest Infestation	It is Serious Threat for Ants, lizards, flying insects and other crawling insects

Any other observations	Nil		
		Preventive Action suggested to customer	Gap should be closed with rubber beading		
13

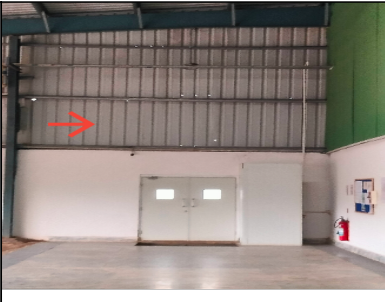
14

Location	Hygiene entrance area		
		Cleaning / sanitation & Housekeeping Issues	Nil		
		Structural Issue (Pest harbourages)	Hygiene entrance doors top side metal sheet lot of holes observed.		
		Access Issues	Nil		
		Description of Pest Infestation	It is Serious Threat for Ants, night time flying insects, lizards		
		Any other observations	Nil		
		Preventive Action suggested to customer	Hole should be closed with silicon sealant		
		Curative action from	We are instructed to Technician for Regular Monitoring.		
15

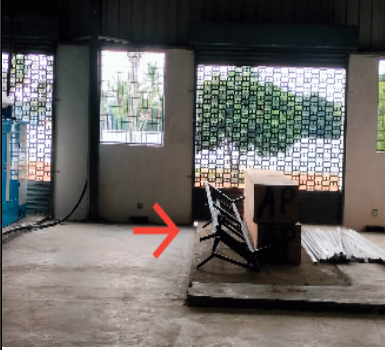
Location	DG area power and panel room		
		Cleaning / sanitation & Housekeeping Issues	Nil		
		Structural Issue (Pest harbourages)	Shutter having lot of gaps. Anad bottom of the shutter gap observed.		
		Access Issues	Nil		
		Description of Pest Infestation	It is Serious Threat for Beetles, snakes, lizards, rodent, ants, flying insects and other crawling insects		
		Any other observations	Nil

Preventive Action suggested to customer	Shutter bottom gap should be closed with rubber beading.middle of the shutter green type mesh should be placed.		
		Curative action from	We are instructed to Technician for Regular Monitoring.		
16

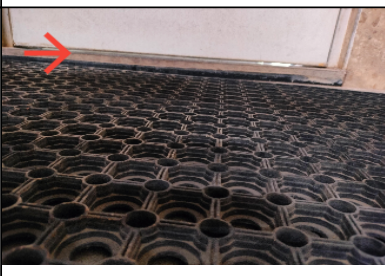
Location	Packing hygiene entrance area		
		Cleaning / sanitation & Housekeeping Issues	Nil		
		Structural Issue (Pest harbourages)	Doors bottom Gap observed		
		Access Issues	Nil		
		Description of Pest Infestation	It is Serious Threat for Ants, lizards, beetles, flying insects and other crawling insects		
		Any other observations	Nil		
		Preventive Action suggested to customer	Gap should be closed with rubber beading		
		Curative action from	We are instructed to Technician for Regular Monitoring.

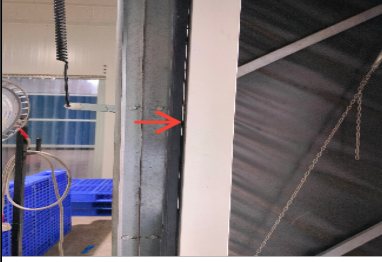
17

Location	Container Loading area		
		Cleaning / sanitation & Housekeeping Issues	Nil		
		Structural Issue (Pest harbourages)	Shutter frame to wall metal frame observed gaps		
		Access Issues	Nil		
		Description of Pest Infestation	It is Serious Threat for Ants, beetles, flying insects, lizards and other crawling insects		
		Any other observations	Nil		
		Preventive Action suggested to customer	Gap should be closed with silicon sealant		
		Curative action from	We are instructed to Technician for Regular Monitoring.		
External Premises				REVIEW DATE	COMPLETION DATE
18

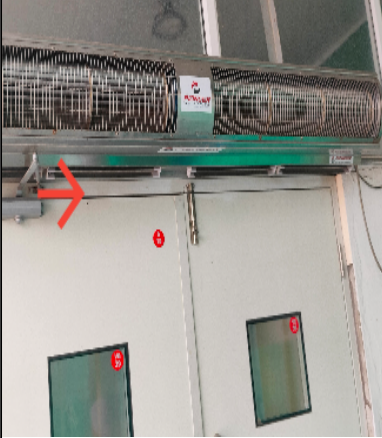
Location	Fruit Washing Entrance area.		
		Cleaning / sanitation & Housekeeping Issues	Nil		
		Structural Issue (Pest harbourages)	At the time inspection air- curtains not worked. Door frame wall edges tiles was broken. Entrance doors bottom Gap observed.		
		Access Issues	Nil		
		Description of Pest Infestation	It is Serious Threat for Beetles, Ants, lizards, snakes,small frogs, flying insects and other crawling insects

Any other observations	Air- curtains velocity not upto the level.		
		Preventive Action suggested to customer	Air- Curtains should be working condition always. Door bottom should be closed with rubber beading. Wall edges tiles should placed. Air- curtains velocity to be checked.		
		Curative action from	We are instructed to Technician for Regular Monitoring.

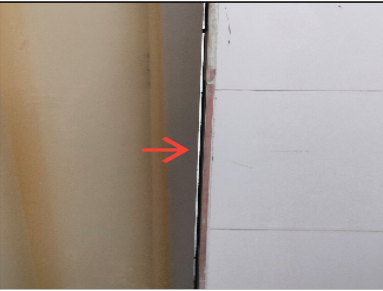
19

Location	Fruit feeding Entrance door area.		
		Cleaning / sanitation & Housekeeping Issues	Nil		
		Structural Issue (Pest harbourages)	Fruit feeding Entrance door frame to wall having Gap.		
		Access Issues	Nil		
		Description of Pest Infestation	It is Serious Threat for Ants, small lizard, crawling insects and night flying insects.		
		Any other observations	Nil		
		Preventive Action suggested to customer	That gap should be closed with white cement or silicone sealant.		
		Curative action from	We are instructed to Technician for Regular Monitoring.		
20

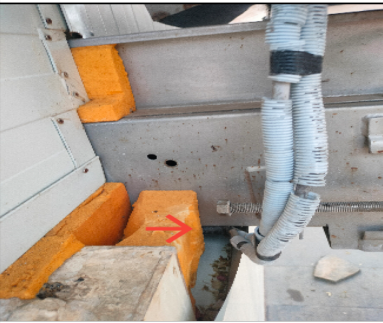
Location	Chambers to fruits inspection centre conveyor line area		
		Cleaning / sanitation & Housekeeping Issues	Bottom of the conveyor line waste accumulated.		
		Structural Issue (Pest harbourages)	Bottom of the conveyor line area metal sheet was fixed but in that area gap observed.		
		Access Issues	Nil		
		Description of Pest Infestation	It is Serious Threat for Ants, lizards, flying insects, beetles and other crawling insects

Any other observations	Nil		
		Preventive Action suggested to customer	Waste should be removed and gap should be closed rubber beading or suitable material without any gaps.		
		Curative action from	We are instructed to Technician for Regular Monitoring.		
21

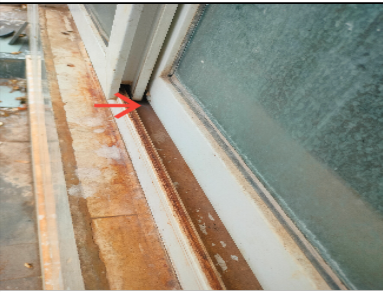
Location	Fruit waste receiving area behind window		
		Cleaning / sanitation & Housekeeping Issues	Nil		
		Structural Issue (Pest harbourages)	Window frame to windows glass frame between gap observed.		
		Access Issues	Nil		
		Description of Pest Infestation	It is Serious Threat for Ants, beetles, cockroach, lizards flying insects and other crawling insects		
		Any other observations	Nil		
		Preventive Action suggested to customer	That gap should be closed with brush or foam		
		Curative action from	We are instructed to Technician for Regular Monitoring.

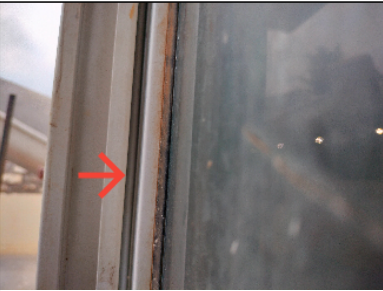
22

Location	Fruit waste receiving behind window area		
		Cleaning / sanitation & Housekeeping Issues	Nil		
		Structural Issue (Pest harbourages)	Window glass to window glass between gap observed		
		Access Issues	Nil		
		Description of Pest Infestation	It is Serious Threat for Beetles, flying insects, small lizards, ants and other crawling insects		
		Any other observations	Nil		
		Preventive Action suggested to customer	That gap should be closed with rubber beading or brush or foam type material.		
		Curative action from	We are instructed to Technician for Regular Monitoring.		
23

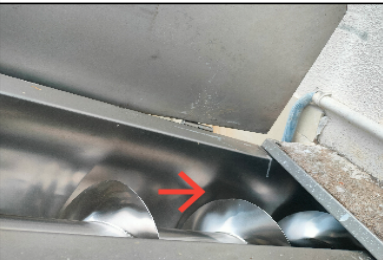
Location	Fruit waste receiving conveyor line.		
		Cleaning / sanitation & Housekeeping Issues	Nil		
		Structural Issue (Pest harbourages)	Fruit waste conveyor line lid was opened condition.		
		Access Issues	Nil		
		Description of Pest Infestation	It is Serious Threat for Beetles, Ants, flying insects, lizards, cockroach and other crawling insects

Any other observations	Nil		
		Preventive Action suggested to customer	Lid should be placed without any gaps.		
		Curative action from	We are instructed to Technician for Regular Monitoring.		
24

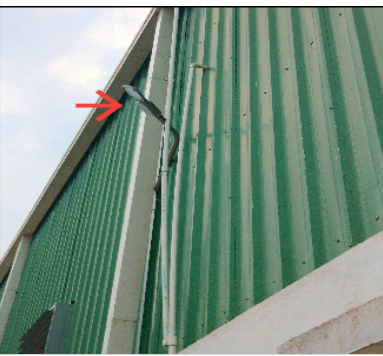
Location	Fruit waste receiving area		
		Cleaning / sanitation & Housekeeping Issues	Nil		
		Structural Issue (Pest harbourages)	I saw all lights are fixed on the processing building metal sheet		
		Access Issues	Nil		
		Description of Pest Infestation	It is Serious Threat for Beetles, ants, lizards, flying insects and other crawling insects		
		Any other observations	Nil		
		Preventive Action suggested to customer	As per AIB and BRC policy lights should be away from the wall. Make separate light poles and light focus wall side only.		
		Curative action from	We are instructed to Technician for Regular Monitoring.

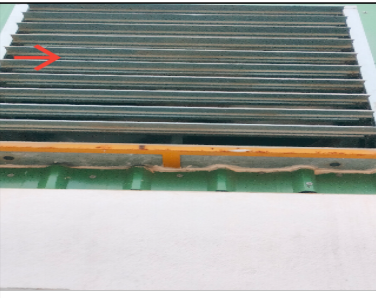
25

Location	All Exhaust fan		
		Cleaning / sanitation & Housekeeping Issues	Nil		
		Structural Issue (Pest harbourages)	We observed the all Exhaust fans outside frame doors not closed properly. Lot of gaps observed.		
		Access Issues	Nil		
		Description of Pest Infestation	It is Serious Threat for Ants, beetles, flying insects, night insects, lizards and other crawling insects		
		Any other observations	Nil		
		Preventive Action suggested to customer	That frame edges PVC strips should be placed.		
		Curative action from	We are instructed to Technician for Regular Monitoring.		
26

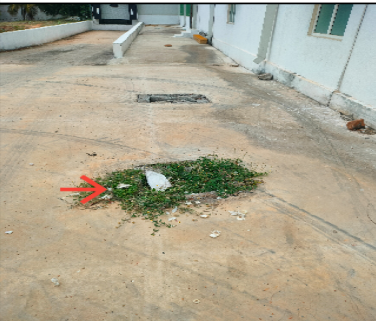
Location	Fruit waste receiving area		
		Cleaning / sanitation & Housekeeping Issues	Small manhole we observed thick vegetation.		
		Structural Issue (Pest harbourages)	Small manhole observed without lid		
		Access Issues	It may any one fall down without knowing at the time of work.		
		Description of Pest Infestation	It is Serious Threat for Ants, rat, snakes, frogs, lizards and other crawling insects

Any other observations	Nil		
		Preventive Action suggested to customer	Vegetation should be removed and lid should be placed without any gaps.		
		Curative action from	We are instructed to Technician for Regular Monitoring.		
27

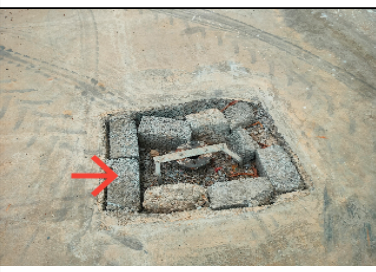
Location	Fruit waste receiving area		
		Cleaning / sanitation & Housekeeping Issues	Nil		
		Structural Issue (Pest harbourages)	Earth manhole was opened condition.		
		Access Issues	Nil		
		Description of Pest Infestation	It is Serious Threat for Ants, frogs, snakes, rodents, lizards and other crawling insects		
		Any other observations	Nil		
		Preventive Action suggested to customer	Lid should be placed without any gaps.		
		Curative action from	We are instructed to Technician for Regular Monitoring.

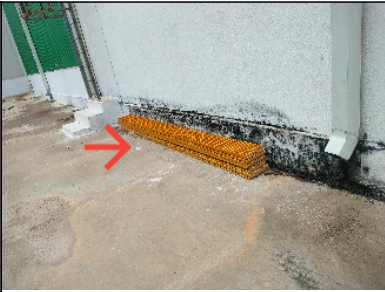
28

Location	Loading area		
		Cleaning / sanitation & Housekeeping Issues	Used materials kept from the wall side. it's major hidden place for pest.		
		Structural Issue (Pest harbourages)	Nil		
		Access Issues	Nil		
		Description of Pest Infestation	It is Serious Threat for Ants, snakes, rodent,lizards and other crawling insects		
		Any other observations	Nil		
		Preventive Action suggested to customer	Don't allow the material near by building and wall.		
		Curative action from	We are instructed to Technician for Regular Monitoring.		
29

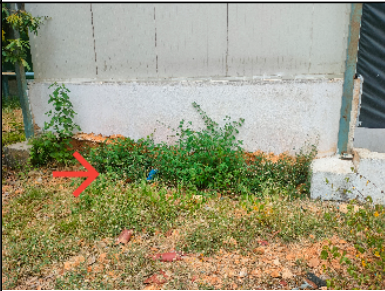
Location	Container Loading area		
		Cleaning / sanitation & Housekeeping Issues	Thick vegetation observed		
		Structural Issue (Pest harbourages)	Nil		
		Access Issues	Nil		
		Description of Pest Infestation	It is Serious Threat for Beetles, ants, lizards, rodent, snakes frogs and other crawling insects		
		Any other observations	Back side of the Building surroundings upto one and half feet cement concrete bed required

Preventive Action suggested to customer	Thick vegetation should be removed on regular basis		
		Curative action from	We are instructed to Technician for Regular Monitoring.		
30

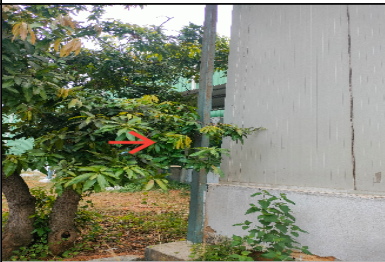
Location	Container Loading area back side.		
		Cleaning / sanitation & Housekeeping Issues	Tree branches fall down on the building side.		
		Structural Issue (Pest harbourages)	Nil		
		Access Issues	Nil		
		Description of Pest Infestation	It is Serious Threat for Ants,. spider, lizards, snakes and other crawling insects		
		Any other observations	Nil		
		Preventive Action suggested to customer	All tree branches should be trim on regular basis		
		Curative action from	We are instructed to Technician for Regular Monitoring.

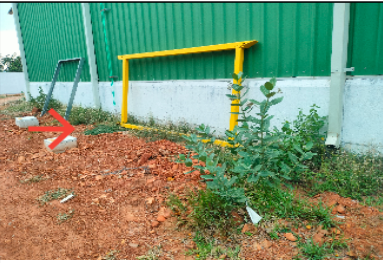
31

Location	FG back out side arra		
		Cleaning / sanitation & Housekeeping Issues	Thick vegetation observed		
		Structural Issue (Pest harbourages)	Nil		
		Access Issues	Nil		
		Description of Pest Infestation	It is Serious Threat for Beetles, rodent, lizards, snake and other crawling insects		
		Any other observations	Nil		
		Preventive Action suggested to customer	Thick vegetation should be removed on regular basis		
		Curative action from	We are instructed to Technician for Regular Monitoring.		
32

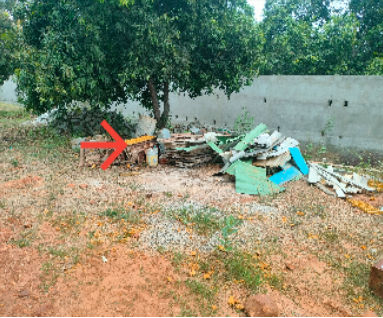
Location	FG back side outer area		
		Cleaning / sanitation & Housekeeping Issues	Lot of used or unused material kept.		
		Structural Issue (Pest harbourages)	Nil		
		Access Issues	Nil		
		Description of Pest Infestation	It is Serious Threat for Ants, snakes, rodents, lizards, flying insects and other crawling insect. It is one of the major hidden place for pest.		
		Any other observations	Nil

Preventive Action suggested to customer	All the material should be removed. Keep the material outside of the factory premises.		
		Curative action from	We are instructed to Technician for Regular Monitoring.		
33

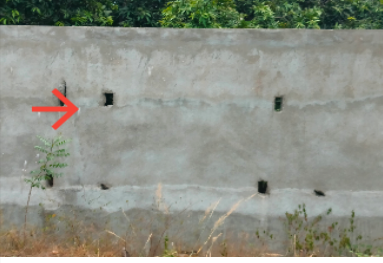
Location	Compound wall		
		Cleaning / sanitation & Housekeeping Issues	Nil		
		Structural Issue (Pest harbourages)	Compound wall having holes.		
		Access Issues	Nil		
		Description of Pest Infestation	It is Serious Threat for Beetles, snakes, rodent, lizards, flying insects and other crawling insects		
		Any other observations	Nil		
		Preventive Action suggested to customer	Gaps should be closed with cement.		
		Curative action from	We are instructed to Technician for Regular Monitoring.

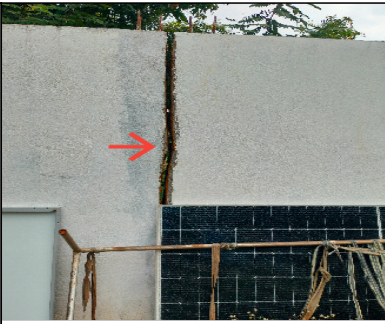
34

Location	Compound wall		
		Cleaning / sanitation & Housekeeping Issues	Used materials kept from Wall sides		
		Structural Issue (Pest harbourages)	Wall to wall gap observed		
		Access Issues	Nil		
		Description of Pest Infestation	It is Serious Threat for Beetles, snakes, frogs, rodent and lizards and other crawling insects.		
		Any other observations	Nil		
		Preventive Action suggested to customer	Wall to wall joint should be closed with cement and concrete. Don't keep the material near by compound wall		
		Curative action from	We are instructed to Technician for Regular Monitoring.		
35

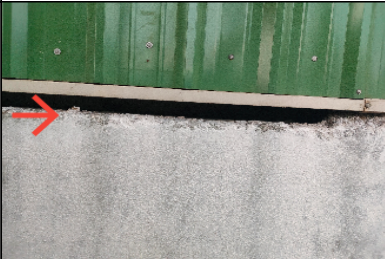
Location	FG ware house back side		
		Cleaning / sanitation & Housekeeping Issues	Nil		
		Structural Issue (Pest harbourages)	Gap observed between wall to wall metal frame.		
		Access Issues	Nil		
		Description of Pest Infestation	It is Serious Threat for Ants, snakes, rodents, lizards and other crawling insects

Any other observations	Nil		
		Preventive Action suggested to customer	Gap should be closed with cement or bricks		
		Curative action from	We are instructed to Technician for Regular Monitoring.		
36

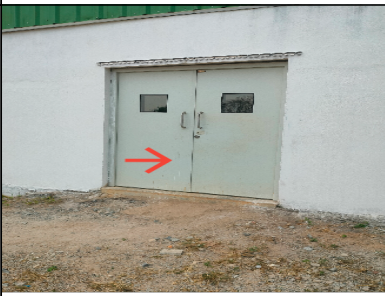
Location	Store behind emergency door		
		Cleaning / sanitation & Housekeeping Issues	Nil		
		Structural Issue (Pest harbourages)	Bottom of the doors and top side of doors Gap observed		
		Access Issues	Nil		
		Description of Pest Infestation	It is Serious Threat for Ants, beetles, flying insects, lizards, small snakes and other crawling insects		
		Any other observations	Nil		
		Preventive Action suggested to customer	Gap should be closed with rubber beading		
		Curative action from	We are instructed to Technician for Regular Monitoring.

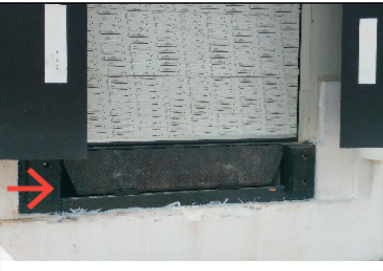
37

Location	Container Loading area		
		Cleaning / sanitation & Housekeeping Issues	Nil		
		Structural Issue (Pest harbourages)	Lift area we observed gaps.		
		Access Issues	Nil		
		Description of Pest Infestation	It is Serious Threat for Beetles, ants, lizards, rodents and snakes and other crawling insects		
		Any other observations	Nil		
		Preventive Action suggested to customer	Gap should be closed with rubber beading or pvc strip		
		Curative action from	We are instructed to Technician for Regular Monitoring.		
38

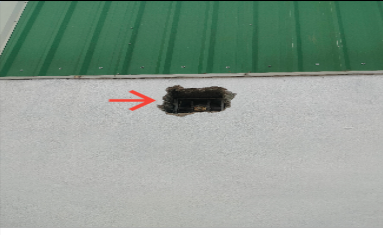
Location	Rast the room area.		
		Cleaning / sanitation & Housekeeping Issues	Nil		
		Structural Issue (Pest harbourages)	Top of the exhaust fan not closed		
		Access Issues	Nk		
		Description of Pest Infestation	It is Serious Threat for Beetles, lizards, flying		
		Any other observations	Nil		
		Preventive Action suggested to customer	Close with cement		
		Curative action from	We are instructed to Technician for Regular Monitoring.

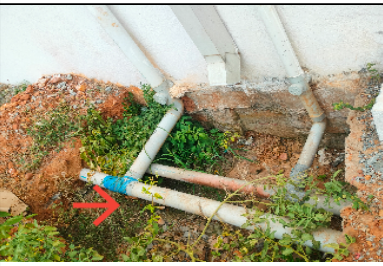
39

Location	Near rest room area		
		Cleaning / sanitation & Housekeeping Issues	Nil		
		Structural Issue (Pest harbourages)	At the inspection we observed small pit.		
		Access Issues	It is dangerous for humans, without knowing may be fall		
		Description of Pest Infestation	It is Serious Threat for Beetles, frog, snakes, rats, lizards and other crawling insects		
		Any other observations	Nil		
		Preventive Action suggested to customer	Pit should be closed with mud		
		Curative action from	We are instructed to Technician for Regular Monitoring.		
40

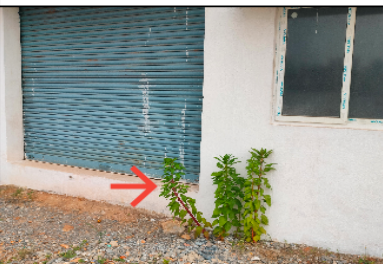
Location	Store shutter area		
		Cleaning / sanitation & Housekeeping Issues	Small tree observed		
		Structural Issue (Pest harbourages)	Nil		
		Access Issues	Nil		
		Description of Pest Infestation	It is Serious Threat for Ants, termite, beetles, lizards, flying insects and other crawling insects		
		Any other observations	Building cracks may be happen

Preventive Action suggested to customer	Don't allow the tree Main building out side		
		Curative action from	We are instructed to Technician for Regular Monitoring.

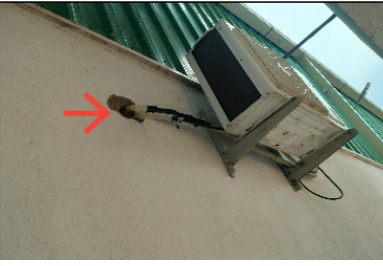
41

Location	Ammonium office room		
		Cleaning / sanitation & Housekeeping Issues	Nil		
		Structural Issue (Pest harbourages)	Ac pipe line gap noticed		
		Access Issues	Nil		
		Description of Pest Infestation	It is Serious Threat for Ants, beetles, lizards and other crawling insects. It is hidden place for pest		
		Any other observations	Nil		
		Preventive Action suggested to customer	Gap should be closed with cement		
		Curative action from	We are instructed to Technician for Regular Monitoring.		
42

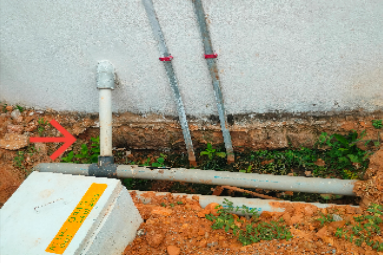
Location	Conference room outer		
		Cleaning / sanitation & Housekeeping Issues	Nil		
		Structural Issue (Pest harbourages)	Small pit observed.		
		Access Issues	Nil		
		Description of Pest Infestation	It is Serious Threat for Ants, beetles, snakes, lizards, rodent, mosquitoes and other crawling insects		
		Any other observations	Nil		
		Preventive Action suggested to customer	Pit should be closed with mud

Curative action from	We are instructed to Technician for Regular Monitoring.		
43

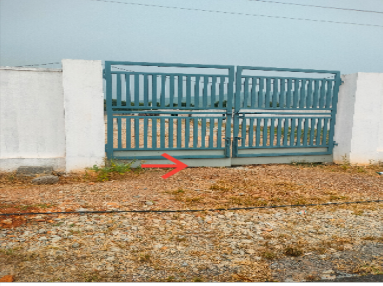
Location	Factory gates		
		Cleaning / sanitation & Housekeeping Issues	Nil		
		Structural Issue (Pest harbourages)	All gates bottom and gate centre gaps observed		
		Access Issues	Nil		
		Description of Pest Infestation	It is Serious Threat for snakes, frogs, lizards, other crawling and small dogs or small monkey		
		Any other observations	Nil		
		Preventive Action suggested to customer	Bottom of the gate should be apply cement concrete and centre of the gate mesh should be placed.		
		Curative action from	We are instructed to Technician for Regular Monitoring.

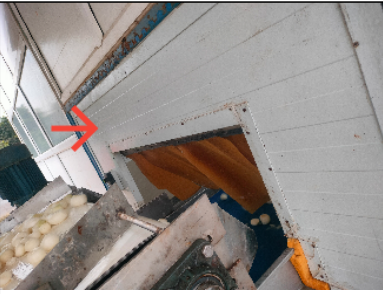
44

Location	Fruit feeding area					
		Cleaning / sanitation & Housekeeping Issues	Nil					
		Structural Issue (Pest harbourages)	At the time of the inspection we observed air- curtains not available in that place					
		Access Issues	Nil					
		Description of Pest Infestation	It is Serious Threat for Ants, lizards,flying insects, rats,snakes and other crawling insects					
		Any other observations	Nil					
		Preventive Action suggested to customer	Air curtains should be placed.					
		Curative action from	We are instructed to Technician for Regular Monitoring.					
Note: Nil								
For Pest Control Experts Authorized Signature. Name: SURESH KUMAR.V Designation: MANAGER Emp.Code: 002 Phone Number: 8248672110
