PEST CONTROL EXPERTS

Facility Name & Address: RMM Food product , Chittoor	Audited On: 14-06-2025
Audited By: SURESH KUMAR.V	
Client Contact Person Name: Mr. Chengal Reddy (Plant Manager)	PC Experts Contact Person Name: SURESH KUMAR.V
Client Contact Person No: 9441911123	PC Experts Contact Person No: 8248672110

Internal Premises			REVIEW DATE	COMPLETION DATE
1

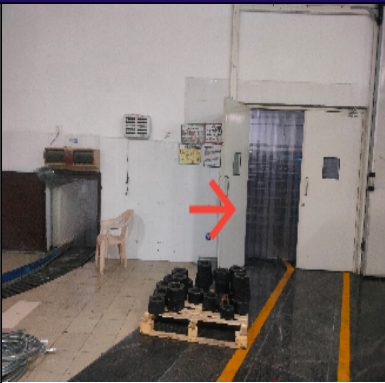
Location	Pulp filled drums moving area.	
		Cleaning / sanitation & Housekeeping Issues	Nil	
		Structural Issue (Pest harbourages)	Doors was opened condition (pulp filling area door was opened condition and filled drums outcome conveyor line strips was kept top side)	
		Access Issues	Fly catcher machine switched off condition.	
		Description of Pest Infestation	It is Serious Threat for Flies, lizards, ants and other crawling insects	
		Any other observations	Nil	
		Preventive Action suggested to customer	All doors should be closed condition with any gaps and strips should be hanged condition. Fly catcher machine should be working condition always.	
		Curative action from	We are instructed to Technician for Regular Monitoring.

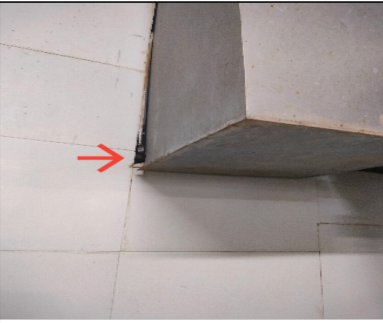
2

Location	Fruit washing to inside received conveyor line area		
		Cleaning / sanitation & Housekeeping Issues	Nil		
		Structural Issue (Pest harbourages)	Gap observed between the wall to fruit receiving conveyor line area		
		Access Issues	Nil		
		Description of Pest Infestation	It is Serious Threat for Ants, flies, lizards and other crawling insects		
		Any other observations	Nil		
		Preventive Action suggested to customer	Gap should be closed with rubber beading or form sealant without any gaps		
		Curative action from	We are instructed to Technician for Regular Monitoring.		
3

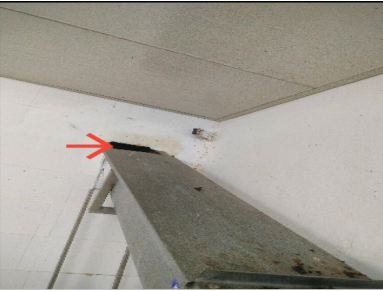
Location	Fruit waste conveyor line		
		Cleaning / sanitation & Housekeeping Issues	Nil		
		Structural Issue (Pest harbourages)	Fruit waste conveyor lid was having gap (not closed properly)		
		Access Issues	Nil		
		Description of Pest Infestation	It is Serious Threat for Ants, lizards, flies and other crawling insects.

Any other observations	Nil		
		Preventive Action suggested to customer	Conveyor lid should be closed without any gaps.		
		Curative action from	We are instructed to Technician for Regular Monitoring.		
4

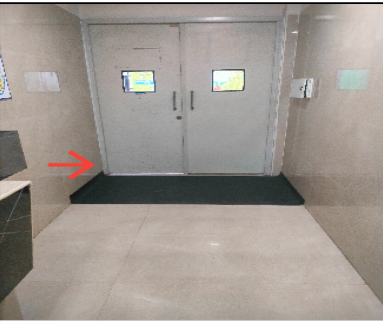
Location	Hygiene Entry area		
		Cleaning / sanitation & Housekeeping Issues	Nil		
		Structural Issue (Pest harbourages)	Door bottom gaps observed		
		Access Issues	Nil		
		Description of Pest Infestation	It is Serious Threat for Ants, lizards, flies and other crawling insects		
		Any other observations	Nil		
		Preventive Action suggested to customer	Door bottom gap should be closed with rubber beading without any gaps and all doors should be closed condition		
		Curative action from	We are instructed to Technician for Regular Monitoring.

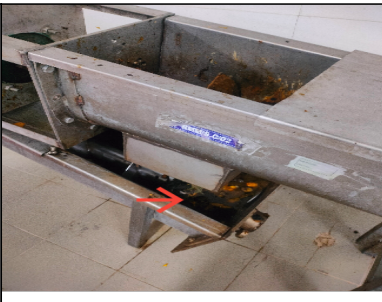
5

Location	Inside of The Fruit waste receiving conveyor line		
		Cleaning / sanitation & Housekeeping Issues	Fruit waste observed in insideof the waste receiving conveyor line		
		Structural Issue (Pest harbourages)	Nil		
		Access Issues	Nil		
		Description of Pest Infestation	It is Serious Threat for flies		
		Any other observations	Nil		
		Preventive Action suggested to customer	Don't allow the fruit waste inside of the plant it should be clean always.		
		Curative action from	We are instructed to Technician for Regular Monitoring.		
External Premises				REVIEW DATE	COMPLETION DATE
6

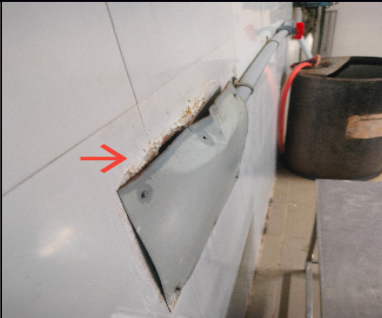
Location	Fruit receiving conveyor line under pipe line hole		
		Cleaning / sanitation & Housekeeping Issues	Nil		
		Structural Issue (Pest harbourages)	Pipe surrounding metal sheet fixed but in that sheet lot of gaps observed (pipe surrounding gap observed)		
		Access Issues	Nil		
		Description of Pest Infestation	It is Serious Threat for Ants, lizards, flies and other crawling insects

Any other observations	Nil		
		Preventive Action suggested to customer	Pipe surrounding should be closed with cement or form sealent without any gaps		
		Curative action from	We are instructed to Technician for Regular Monitoring.		
7

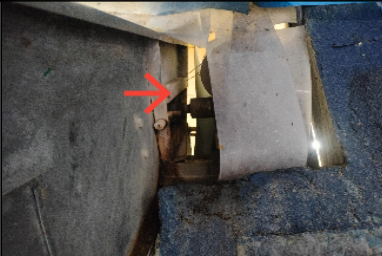
Location	Fruit washing conveyor line to wall		
		Cleaning / sanitation & Housekeeping Issues	Nil		
		Structural Issue (Pest harbourages)	Gap observed between the fruit conveyor line to wall		
		Access Issues	Nil		
		Description of Pest Infestation	It is Serious Threat for Ants, flies and lizards.		
		Any other observations	Nil		
		Preventive Action suggested to customer	Gap should be closed with rubber beading or form sealent without any gaps.		
		Curative action from	We are instructed to Technician for Regular Monitoring.

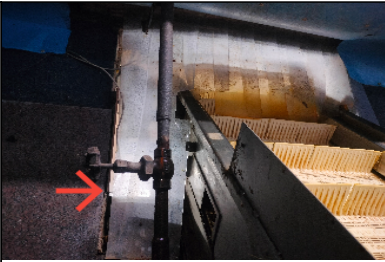
8

Location	Fruit receiving conveyor line area		
		Cleaning / sanitation & Housekeeping Issues	Nil		
		Structural Issue (Pest harbourages)	Gap observed between the fruit receiving conveyor to wall		
		Access Issues	Nil		
		Description of Pest Infestation	It is Serious Threat for flies, ant and lizards.		
		Any other observations	Nil		
		Preventive Action suggested to customer	Gap should be closed with sheet or mesh		
		Curative action from	We are instructed to Technician for Regular Monitoring.
