PEST CONTROL EXPERTS

Facility Name & Address: Tasa Food PVT LTD - unit -2, Chittoor	Audited On: 14-06-2025
Audited By: SURESH KUMAR.V	
Client Contact Person Name: Mr. Ramki (Plant Manager)	PC Experts Contact Person Name: SURESH KUMAR.V
Client Contact Person No: 9700553433	PC Experts Contact Person No: 8248672110

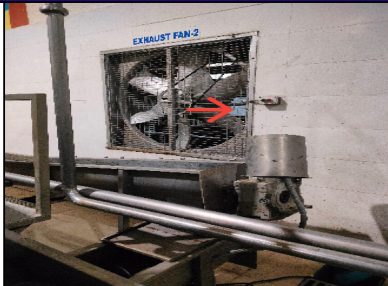
Internal Premises			REVIEW DATE	COMPLETION DATE
1

Location	Inside of plant	
		Cleaning / sanitation & Housekeeping Issues	Nil	
		Structural Issue (Pest harbourages)	Nil	
		Access Issues	At the time of inspection we noticed exhaust fan not worked and gaps noticed.	
		Description of Pest Infestation	It is Serious Threat for Ants, flies, lizards and other crawling insects	
		Any other observations	Nil	
		Preventive Action suggested to customer	Exhaust fan should be working condition.	
		Curative action from	We are instructed to Technician for Regular Monitoring.

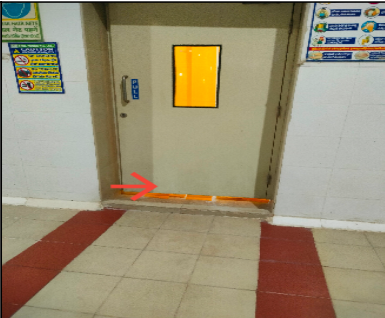
2

Location	Hygiene Entry area		
		Cleaning / sanitation & Housekeeping Issues	Nil		
		Structural Issue (Pest harbourages)	Door bottom gap observed		
		Access Issues	Nil		
		Description of Pest Infestation	It is Serious Threat for Ants, flies, lizards, rodent, snakes and other crawling insects		
		Any other observations	Hygiene out side door not closed properly		
		Preventive Action suggested to customer	Hygiene out side and inside doors should be closed and bottom gap should be closed with rubber beading or metal sheet without any gaps		
3

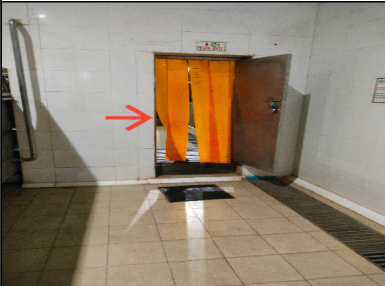
Curative action from	We are instructed to Technician for Regular Monitoring.		
		Location	Emergency door entry		
		Cleaning / sanitation & Housekeeping Issues	Nil		
		Structural Issue (Pest harbourages)	Door was always opened condition		
		Access Issues	Nil		
		Description of Pest Infestation	It is Serious Threat for flies, Ants, rodent, lizards and other crawling insects

Any other observations	Out side aircutain not available		
4

Preventive Action suggested to customer	Plant all doors should be closed condition. All entry area air curtains should be placed.		
		Curative action from	We are instructed to Technician for Regular Monitoring.		
		Location	Fruit wash conveyor line to Wall		
		Cleaning / sanitation & Housekeeping Issues	Nil		
		Structural Issue (Pest harbourages)	Gap observed between the wall to fruit receiving conveyor line		
		Access Issues	Nil		
		Description of Pest Infestation	It is Serious Threat for flies, beetles,Ants, lizards and other crawling insects		
		Any other observations	Air curtains and pvc strips not fixed in this place		
		Preventive Action suggested to customer	Air curtains should be placed. Pvc strips should be placed. Side gaps should be closed with metal sheet without any gaps		
		Curative action from	We are instructed to Technician for Regular Monitoring.

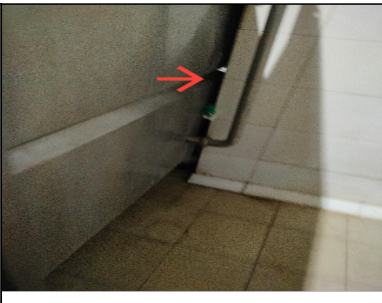
5

Location	Fruit washing conveyor		
		Cleaning / sanitation & Housekeeping Issues	Nil		
		Structural Issue (Pest harbourages)	Wall to conveyor gap observed		
		Access Issues	Nil		
		Description of Pest Infestation	It is Serious Threat for flies, ants, lizards and other crawling insects		
		Any other observations	Nil		
		Preventive Action suggested to customer	Gap should be closed with rubber beading or form sealent		
		Curative action from	We are instructed to Technician for Regular Monitoring.		
External Premises				REVIEW DATE	COMPLETION DATE
6

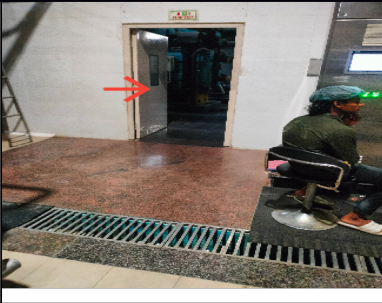
Location	Emergency exit door		
		Cleaning / sanitation & Housekeeping Issues	Nil		
		Structural Issue (Pest harbourages)	Doors was opened condition.		
		Access Issues	Nil		
		Description of Pest Infestation	It is Serious Threat for Ants, beetles, flies, lizards and other crawling insects		
		Any other observations	Pvc strips and air curtains not available in this area.

Preventive Action suggested to customer	Doors should be closed condition with always. Pvc strips should be placed and Aircutain should be placed.		
		Curative action from	We are instructed to Technician for Regular Monitoring.		
7

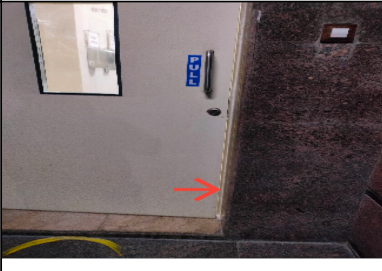
Location	Hygiene Entry door		
		Cleaning / sanitation & Housekeeping Issues	Nil		
		Structural Issue (Pest harbourages)	Door not closed		
		Access Issues	Nil		
		Description of Pest Infestation	It is Serious Threat for Ants, flies, lizards and other crawling insects		
		Any other observations	Nil		
		Preventive Action suggested to customer	Doors should be closed condition always.		
		Curative action from	We are instructed to Technician for Regular Monitoring.		
Note: Nil
