PEST CONTROL EXPERTS

Facility Name & Address: Tasa Foods Pvt Ltd unit -2, Chittoor	Audited On: 15-06-2025
Audited By: SURESH KUMAR.V	
Client Contact Person Name: Mr. Sumeer Ahmed (Plant Manager)	PC Experts Contact Person Name: SURESH KUMAR.V
Client Contact Person No: 9177740550	PC Experts Contact Person No: 8248672110

Internal Premises				REVIEW DATE	COMPLETION DATE
1

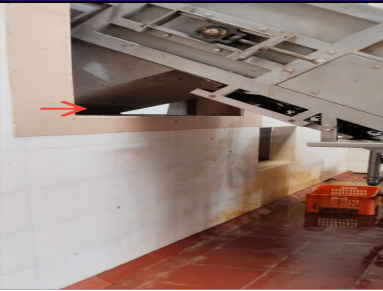
Location	Fruit washing conveyor line		
		Cleaning / sanitation & Housekeeping Issues	Nil		
		Structural Issue (Pest harbourages)	Fruit washing conveyor line to Wall gap noticed		
		Access Issues	Nil		
		Description of Pest Infestation	It is Serious Threat for Beetles, flies, lizards and other crawling insects		
		Any other observations	Nil		
		Preventive Action suggested to customer	Gap should be closed with mesh or metal sheet without any gaps		
		Curative action from	We are instructed to Technician for Regular Monitoring.

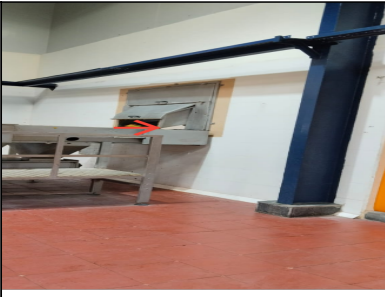
2

Location	Fruit washing conveyor line area		
		Cleaning / sanitation & Housekeeping Issues	Nil		
		Structural Issue (Pest harbourages)	Gap noticed between the wall to conveyor line		
		Access Issues	Nil		
		Description of Pest Infestation	It is Serious Threat for Beetles, ants, lizards, flies and other crawling insects		
		Any other observations	Nil		
		Preventive Action suggested to customer	Gap should be closed with pvc strips or metal sheet without any gaps		
		Curative action from	We are instructed to Technician for Regular Monitoring.		
3

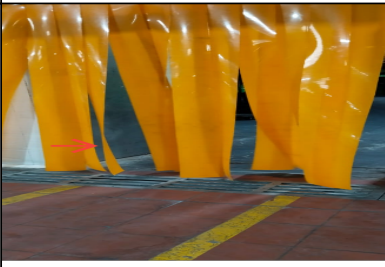
Location	Emergency exit door area		
		Cleaning / sanitation & Housekeeping Issues	Nil		
		Structural Issue (Pest harbourages)	Doors are opened condition		
		Access Issues	Nil		
		Description of Pest Infestation	It is Serious Threat for Ants, flies, lizards and other crawling insects		
		Any other observations	Nil		
		Preventive Action suggested to customer	All entry Doors should be closed without any gaps

Curative action from	We are instructed to Technician for Regular Monitoring.		
4

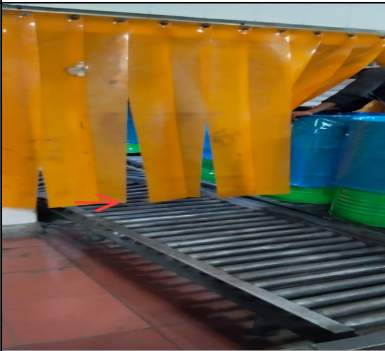
Location	Drums moving area (Filling area)		
		Cleaning / sanitation & Housekeeping Issues	Nil		
		Structural Issue (Pest harbourages)	Gap noticed between the wall to pvc strips and drums moving line to floor bottom		
		Access Issues	Nil		
		Description of Pest Infestation	It is Serious Threat for Ants, rodent, lizards, flies and other crawling insects		
		Any other observations	Nil		
		Preventive Action suggested to customer	Bottom floor gap should be closed with metal sheet without any gaps. PVC strips should be placed without any gaps.		
		Curative action from	We are instructed to Technician for Regular Monitoring.

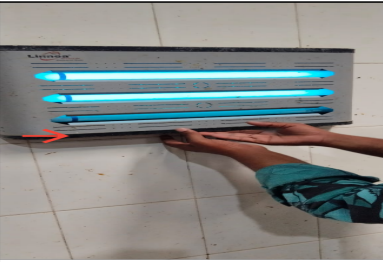
5

Location	Processing hall		
		Cleaning / sanitation & Housekeeping Issues	Nil		
		Structural Issue (Pest harbourages)	Nil		
		Access Issues	Fly catcher machine working condition but one light not illuminated.		
		Description of Pest Infestation	It is Serious Threat for flies		
		Any other observations	Nil		
		Preventive Action suggested to customer	Light should be replaced.		
		Curative action from	We are instructed to Technician for Regular Monitoring.
