PEST CONTROL EXPERTS

Facility Name & Address: ISHAA FOOD PRODUCTS PVT LTD , Chittoor	Audited On: 12-06-2025
Audited By: SURESH KUMAR.V	
Client Contact Person Name: Mr. Sathish (GM)	PC Experts Contact Person Name: SURESH KUMAR.V
Client Contact Person No: 9949260630	PC Experts Contact Person No: 8248672110

FACILITY SURROUNDING

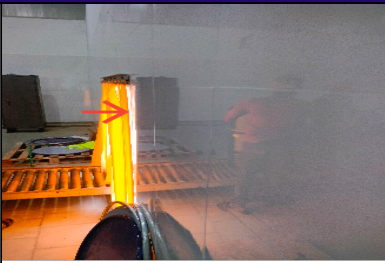
Internal Premises			REVIEW DATE	COMPLETION DATE
1

Location	Drums receiving area.	
		Cleaning / sanitation & Housekeeping Issues	Nil	
		Structural Issue (Pest harbourages)	PVC strips to Wall gap observed	
		Access Issues	Nil	
		Description of Pest Infestation	It is Serious Threat for Beetles, lizards, flies, ants and other crawling insects	
		Any other observations	Nil	
		Preventive Action suggested to customer	PVC strips should be placed without any gaps.	
		Curative action from	We are instructed to Technician for Regular Monitoring.

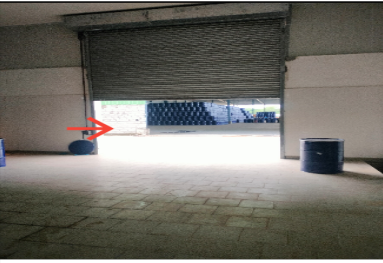
2

Location	Processing hall shutter area		
		Cleaning / sanitation & Housekeeping Issues	Nil		
		Structural Issue (Pest harbourages)	Shutter was opened condition		
		Access Issues	Nil		
		Description of Pest Infestation	It is Serious Threat for Ants, lizards, flies, snake, rodent, bird's		
		Any other observations	Nil		
		Preventive Action suggested to customer	Shutter should be closed without any gaps		
		Curative action from	We are instructed to Technician for Regular Monitoring.		
3

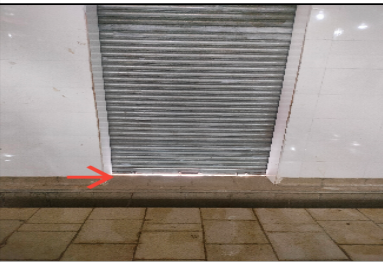
Location	Emergency exit shutters		
		Cleaning / sanitation & Housekeeping Issues	Nil		
		Structural Issue (Pest harbourages)	Shutters bottom gap observed		
		Access Issues	Nil		
		Description of Pest Infestation	It is Serious Threat for Ants, lizards, flies and other crawling insects		
		Any other observations	Nil		
		Preventive Action suggested to customer	Gap should be closed with rubber beading		
		Curative action from	We are instructed to Technician for Regular Monitoring.

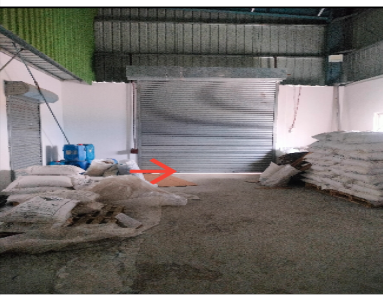
4

Location	Storage area		
		Cleaning / sanitation & Housekeeping Issues	Nil		
		Structural Issue (Pest harbourages)	Shutters bottom gap observed		
		Access Issues	Material store at wall corners		
		Description of Pest Infestation	It is Serious Threat for Beetles, ants, lizards, rodent, snakes and other crawling insects		
		Any other observations	Nil		
		Preventive Action suggested to customer	Shutters bottom should be closed with rubber beading. Wall to material gap should be required upto 1&1/2 feet.		
		Curative action from	We are instructed to Technician for Regular Monitoring.

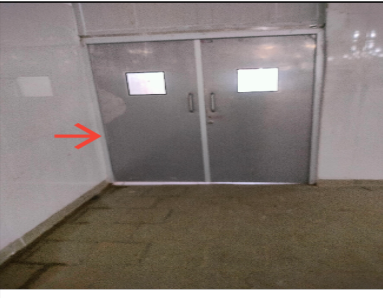
5

Location	Hygiene to plant entry door area		
		Cleaning / sanitation & Housekeeping Issues	Nil		
		Structural Issue (Pest harbourages)	Door bottom gap observed		
		Access Issues	Nil		
		Description of Pest Infestation	It is Serious Threat for Ants, lizards, flies and other crawling insects		
		Any other observations	Nil		
		Preventive Action suggested to customer	Gap should be closed with rubber beading without any gaps		
		Curative action from	We are instructed to Technician for Regular Monitoring.		
6

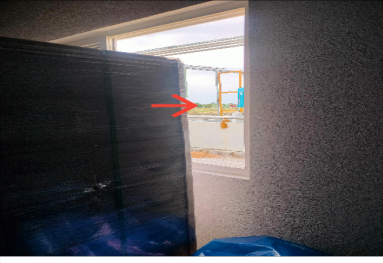
Location	Storage area		
		Cleaning / sanitation & Housekeeping Issues	Nil		
		Structural Issue (Pest harbourages)	Windows doors was opened condition		
		Access Issues	Nil		
		Description of Pest Infestation	It is Serious Threat for Ants, bettle, flies, lizards and other crawling insects		
		Any other observations	Nil		
		Preventive Action suggested to customer	All windows doors should be closed without any gaps.

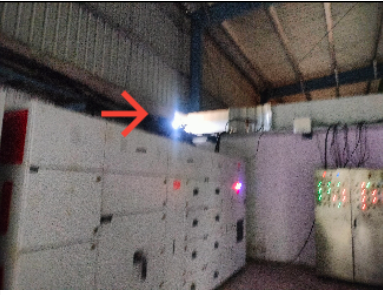
Location	Power panel room		
		Cleaning / sanitation & Housekeeping Issues	Nil		
		Structural Issue (Pest harbourages)	Cable dock line to wall sheets gap observed.		
		Access Issues	Nil		
		Description of Pest Infestation	It is Serious Threat for Ants, rodent, snakes, lizards and other crawling insects		
		Any other observations	Nil		
		Preventive Action suggested to customer	Gap should be closed with sheet or mesh without any gaps.		
		Curative action from	We are instructed to Technician for Regular Monitoring.

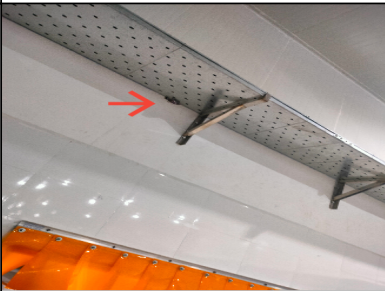
Location	Processing Hall inside		
		Cleaning / sanitation & Housekeeping Issues	Nil		
		Structural Issue (Pest harbourages)	Cable dock line area we observed hole		
		Access Issues	Nil		
		Description of Pest Infestation	It is Serious Threat for Ants, beetles, lizards, flies and other crawling insects		
		Any other observations	Nil		
		Preventive Action suggested to customer	Hole should be closed with cement or form sealent without any gaps

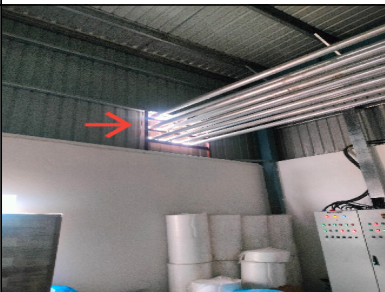
Location	Power panel room area		
		Cleaning / sanitation & Housekeeping Issues	Nil		
		Structural Issue (Pest harbourages)	Gap observed between the wall sheets to pipe lines		
		Access Issues	Nil		
		Description of Pest Infestation	It is Serious Threat for Ants, beetles, flies, lizards and other crawling insects		
		Any other observations	Nil		
		Preventive Action suggested to customer	Gap should be closed metal sheet or form sealent without any gaps		
		Curative action from	We are instructed to Technician for Regular Monitoring.

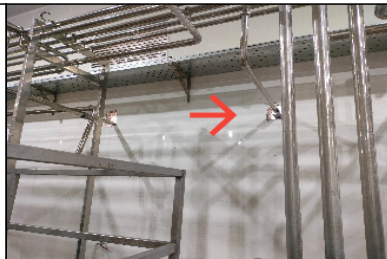
11

Location	Processing hall inside		
		Cleaning / sanitation & Housekeeping Issues	Nil		
		Structural Issue (Pest harbourages)	Hole observed the between the pipe to Wall		
		Access Issues	Nil		
		Description of Pest Infestation	It is Serious Threat for Ants, lizards, flies and other crawling insects		
		Any other observations	Nil		
		Preventive Action suggested to customer	Hole should be closed cement or form sealent		
		Curative action from	We are instructed to Technician for Regular Monitoring.		
12

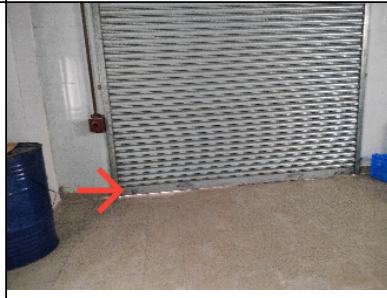
Location	Office area		
		Cleaning / sanitation & Housekeeping Issues	Nil		
		Structural Issue (Pest harbourages)	Shutter bottom gap observed		
		Access Issues	Nil		
		Description of Pest Infestation	It is Serious Threat for Ants, flies, lizards and other crawling		
		Any other observations	Nil		
		Preventive Action suggested to customer	Shutters bottom gap should be closed with rubber beading without any gaps.

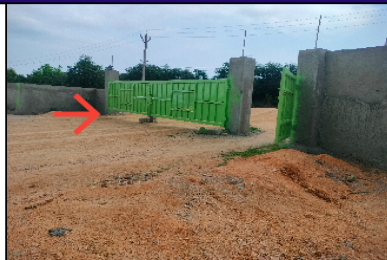
Location	Factory Main gate		
		Cleaning / sanitation & Housekeeping Issues	Nil		
		Structural Issue (Pest harbourages)	Gate bottom gap observed		
		Access Issues	Nil		
		Description of Pest Infestation	It is Serious Threat for dogs, snakes, rodents, lizards and other crawling insects		
		Any other observations	Nil		
		Preventive Action suggested to customer	Gate bottom metal sheet be fixed without any gaps		
		Curative action from	We are instructed to Technician for Regular Monitoring.

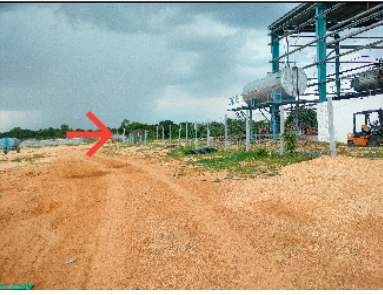
14

Location	Factory fencing area		
		Cleaning / sanitation & Housekeeping Issues	Nil		
		Structural Issue (Pest harbourages)	Compound Wall not build fully (fencing line observed)		
		Access Issues	Nil		
		Description of Pest Infestation	It is Serious Threat for Beetles, dogs, forest animals, monkey, snakes, rodents, lizards and other crawling insects		
		Any other observations	Nil		
		Preventive Action suggested to customer	Compound Wall should be required from all sides.		
		Curative action from	We are instructed to Technician for Regular Monitoring.		
15

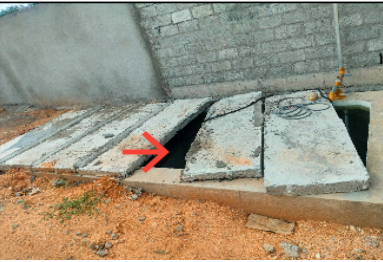
Location	Water storage tank area (Main gate left side)		
		Cleaning / sanitation & Housekeeping Issues	Nil		
		Structural Issue (Pest harbourages)	Lid not closed properly		
		Access Issues	Nil		
		Description of Pest Infestation	It is Serious Threat for Beetles, mosquito, snakes and other crawling insects		
		Any other observations	Man movement if is there,it may fall down.

Preventive Action suggested to customer	Tank lid should be closed always.		
		Curative action from	We are instructed to Technician for Regular Monitoring.		
16

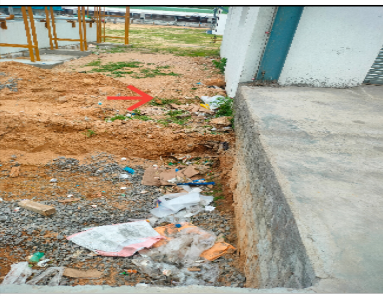
Location	Main building out side		
		Cleaning / sanitation & Housekeeping Issues	Thick vegetation observed		
		Structural Issue (Pest harbourages)	Wall and floor junction cement concrete not available		
		Access Issues	Nil		
		Description of Pest Infestation	It is Serious Threat for Ants, snakes, lizards, rodent and other crawling insects		
		Any other observations	Nil		
		Preventive Action suggested to customer	Wall and floor junction upto 2 feet cement concrete should be required.		
		Curative action from	We are instructed to Technician for Regular Monitoring.

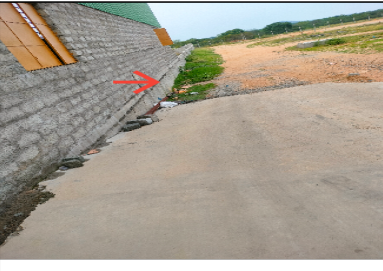
17

Location	Finished godown out side		
		Cleaning / sanitation & Housekeeping Issues	Thick vegetation observed		
		Structural Issue (Pest harbourages)	Nil		
		Access Issues	Nil		
		Description of Pest Infestation	It is Serious Threat for Beetles, snakes, rodents, Bird's, lizards and other crawling insects		
		Any other observations	Nil		
		Preventive Action suggested to customer	Thick vegetation should be trim on regular basis.		
		Curative action from	We are instructed to Technician for Regular Monitoring.		
18

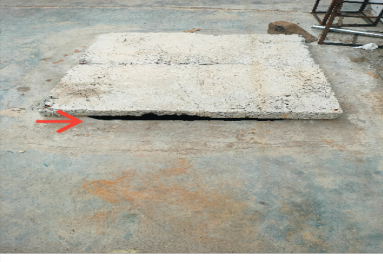
Location	FG to processing Hall middle area		
		Cleaning / sanitation & Housekeeping Issues	Nil		
		Structural Issue (Pest harbourages)	Lid not closed properly		
		Access Issues	Nil		
		Description of Pest Infestation	It is Serious Threat for Beetles, mosquito, flies, lizards, snakes and other crawling insects		
		Any other observations	Nil		
		Preventive Action suggested to customer	Lid should be closed without any gaps.

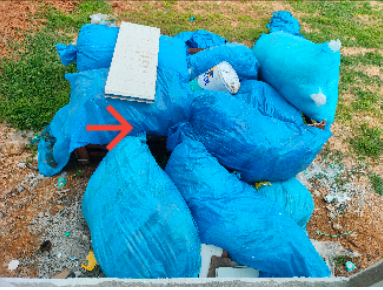
Location	GM office outside area		
		Cleaning / sanitation & Housekeeping Issues	Unused metrial dumped		
		Structural Issue (Pest harbourages)	Nil		
		Access Issues	Nil		
		Description of Pest Infestation	It is Serious Threat for Ants, beetles, flies, rodent, snakes and other crawling insects		
		Any other observations	Nil		
		Preventive Action suggested to customer	Don't allow the unwanted material near by Plant surrounding. Keep separate place.		
		Curative action from	We are instructed to Technician for Regular Monitoring.

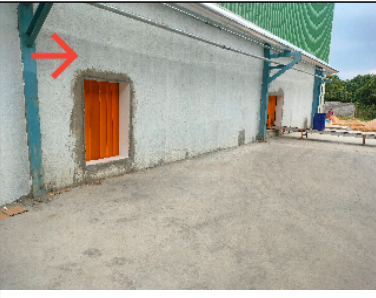
20

Location	Empty and filled drums in and out area.		
		Cleaning / sanitation & Housekeeping Issues	Nil		
		Structural Issue (Pest harbourages)	Pvc strips to wall gap observed and Aircutain not fixed.		
		Access Issues	Nil		
		Description of Pest Infestation	It is Serious Threat for Ants, beetles, flies, rodent, lizards and other crawling insects.		
		Any other observations	Nil		
		Preventive Action suggested to customer	PVC strips should be placed without any gaps. Aircutain should be placed.		
		Curative action from	We are instructed to Technician for Regular Monitoring.		
21

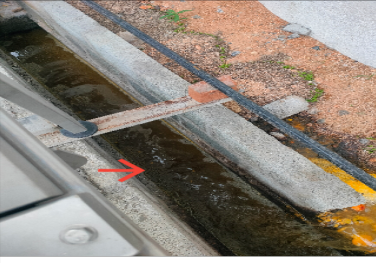
Location	Drainage area		
		Cleaning / sanitation & Housekeeping Issues	Fruit waste was stagnated in drainage line		
		Structural Issue (Pest harbourages)	Nil		
		Access Issues	Nil		
		Description of Pest Infestation	It is Serious Threat for Ants, beetles, flies, and other crawling insects.		
		Any other observations	Nil

Preventive Action suggested to customer	Drainage should be clean on regular basis.		
		Curative action from	We are instructed to Technician for Regular Monitoring.		
22

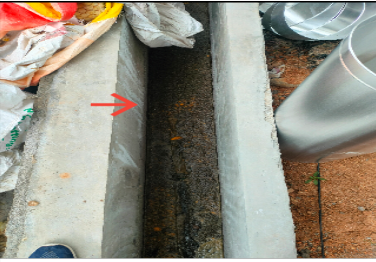
Location	Drainage line area		
		Cleaning / sanitation & Housekeeping Issues	Fruit waste stagnated in drainage line		
		Structural Issue (Pest harbourages)	Nil		
		Access Issues	Nil		
		Description of Pest Infestation	It is Serious Threat for Beetles, ants, flies, other crawling		
		Any other observations	Nil		
		Preventive Action suggested to customer	Drainage should be clean on regular basis		
		Curative action from	We are instructed to Technician for Regular Monitoring.

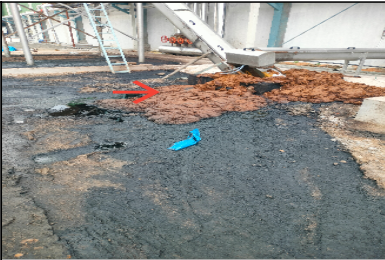
23

Location	Fruit waste receiving area		
		Cleaning / sanitation & Housekeeping Issues	Lot of waste accumulated, not cleaned properly		
		Structural Issue (Pest harbourages)	Nil		
		Access Issues	Nil		
		Description of Pest Infestation	It is Serious Threat for Ants, bird, flies, beetle other crawling insects		
		Any other observations	Nil		
		Preventive Action suggested to customer	Don't allow the waste, it should be clean spot itself.		
		Curative action from	We are instructed to Technician for Regular Monitoring.		
24

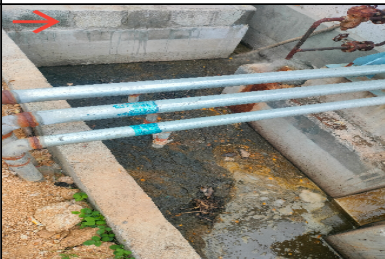
Location	Waste water collecting tank		
		Cleaning / sanitation & Housekeeping Issues	Fruit waste stagnated		
		Structural Issue (Pest harbourages)	Nil		
		Access Issues	Nil		
		Description of Pest Infestation	It is Serious Threat for Ants, flies, beetles and other crawling insects.		
		Any other observations	Nil		
		Preventive Action suggested to customer	Don't allow the waste, it should be clean spot itself.

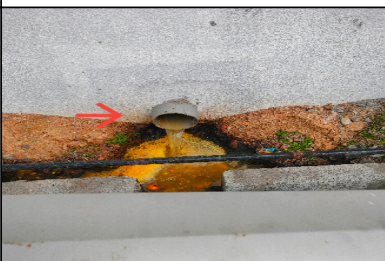
Location	Waste water running pipe line		
		Cleaning / sanitation & Housekeeping Issues	Nil		
		Structural Issue (Pest harbourages)	Plumbing work not completed		
		Access Issues	Nil		
		Description of Pest Infestation	It is Serious Threat for Ants, flies, beetles and other crawling		
		Any other observations	Nil		
		Preventive Action suggested to customer	Pipe line should be put into the running drainage line area		
		Curative action from	We are instructed to Technician for Regular Monitoring.

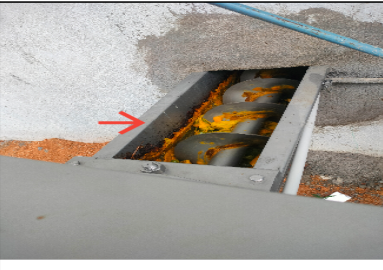
26

Location	Fruit waste receiving conveyor line		
		Cleaning / sanitation & Housekeeping Issues	Nil		
		Structural Issue (Pest harbourages)	Lid not placed		
		Access Issues	Nil		
		Description of Pest Infestation	It is Serious Threat for Ants, flies, lizards and other crawling insects		
		Any other observations	Nil		
		Preventive Action suggested to customer	Lid should be placed without any gaps		
		Curative action from	We are instructed to Technician for Regular Monitoring.		
27

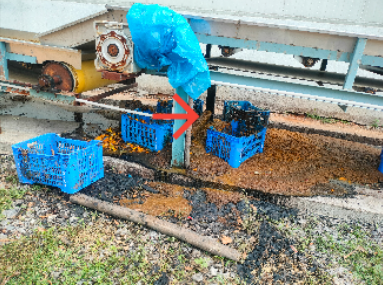
Location	ECRC fruit receiving conveyor line		
		Cleaning / sanitation & Housekeeping Issues	Each conveyor joint area fruit waste fall down on the floor.		
		Structural Issue (Pest harbourages)	Nil		
		Access Issues	Nil		
		Description of Pest Infestation	It is Serious Threat for Beetles, flies, ants, other crawling insects		
		Any other observations	Nil		
		Preventive Action suggested to customer	Don't allow the waste. It should be clean spot itself.
