## PEST CONTROL EXPERTS

Facility Name & Address: M/s. FROZEN TROPICAL PVT LTD , Chittoor	Audited On: 12-08-2025
Audited By: SURESH KUMAR.V	
Client Contact Person Name: Mr. Surendra (QC)	PC Experts Contact Person Name: SURESH KUMAR.V
Client Contact Person No: 7702187499	PC Experts Contact Person No: 8248672110

### FACILITY SURROUNDING

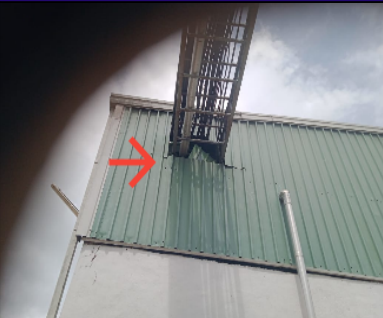
1

Location	Electrical power cable line area		
	Cleaning / sanitation & Housekeeping Issues	Nil		
	Structural Issue (Pest harbourages)	Electrical power cable trench to wall sheet gap observed.		
	Access Issues	Nil		
	Description of Pest Infestation	It is Serious Threat for Beetles, lizards, snakes, monkey, flying insects and other crawling insects		
	Any other observations	Nil		
	Preventive Action suggested to customer	Gap should be closed with form and metal sheet without any gaps.		
	Curative action from	We are instructed to Technician for Regular Monitoring.

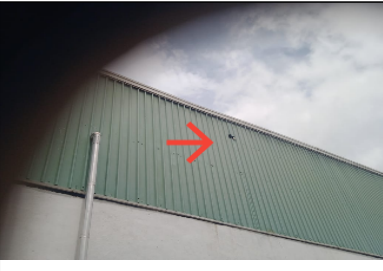
Location	Main building Back side		
		Cleaning / sanitation & Housekeeping Issues	Nil		
		Structural Issue (Pest harbourages)	Metal sheet hole observed		
		Access Issues	Nil		
		Description of Pest Infestation	It is Serious Threat for Ants, beetle, flying insects, lizards and other crawling insects		
		Any other observations	Nil		
		Preventive Action suggested to customer	Hole should be closed with form sealent		
		Curative action from	We are instructed to Technician for Regular Monitoring.		
2

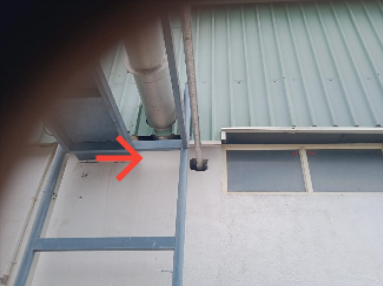
Location	Waste receiving conveyor line area		
		Cleaning / sanitation & Housekeeping Issues	Nil		
		Structural Issue (Pest harbourages)	Fruit waste receiving conveyor line and ss pipe to wall joint hole observed.		
		Access Issues	Nil		
		Description of Pest Infestation	It is Serious Threat for beetle, flying insects, lizards and other crawling insects		
		Any other observations	Nil		
		Preventive Action suggested to customer	Gap should be closed with form sealent or cement

Curative action from	We are instructed to Technician for Regular Monitoring.		
3

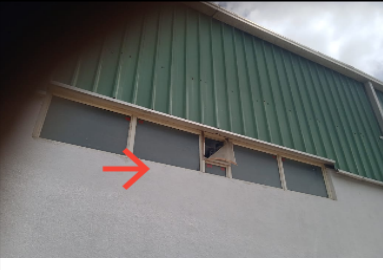
4

Location	Main building emergency door top side		
		Cleaning / sanitation & Housekeeping Issues	Nil		
		Structural Issue (Pest harbourages)	Ventilation mesh was damaged condition		
		Access Issues	Nil		
		Description of Pest Infestation	It is Serious Threat for Beetles, flying insects, lizards and other crawling insects		
		Any other observations	Nil		
		Preventive Action suggested to customer	New mesh should be placed in all areas		
		Curative action from	We are instructed to Technician for Regular Monitoring.

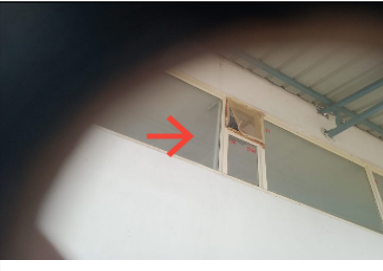
Location	Main building front side		
		Cleaning / sanitation & Housekeeping Issues	Nil		
		Structural Issue (Pest harbourages)	Mesh was not fixed properly		
		Access Issues	Nil		
		Description of Pest Infestation	It is Serious Threat for Ants, beetle, flying insects, lizards and other crawling insects		
		Any other observations	Nil		
		Preventive Action suggested to customer	Mesh should be placed without any gaps		
		Curative action from	We are instructed to Technician for Regular Monitoring.		
5

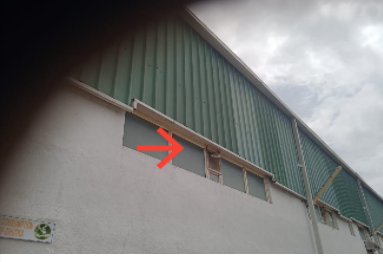
Location	Main building Back side		
		Cleaning / sanitation & Housekeeping Issues	Nil		
		Structural Issue (Pest harbourages)	Mesh not properly fixed.		
		Access Issues	Nil		
		Description of Pest Infestation	It is Serious Threat for Ants, beetle, lizards, flying insects and other crawling insects		
		Any other observations	Nil		
		Preventive Action suggested to customer	Mesh should be placed without any gaps

Curative action from	We are instructed to Technician for Regular Monitoring.		
6

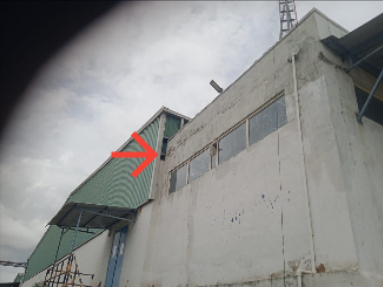
7

Location	Main building emergency door top side		
		Cleaning / sanitation & Housekeeping Issues	Nil		
		Structural Issue (Pest harbourages)	Wall metal sheet to sheet gap observed		
		Access Issues	Nil		
		Description of Pest Infestation	It is Serious Threat for Ants, beetle, flying insects, lizards and other crawling insects		
		Any other observations	Nil		
		Preventive Action suggested to customer	Gap should be closed with cement or foam sealant or sheet		
		Curative action from	We are instructed to Technician for Regular Monitoring.

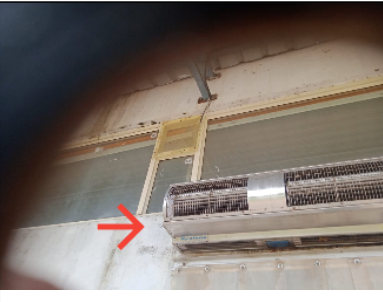
Location	Emergency door exit					
		Cleaning / sanitation & Housekeeping Issues	Nil					
		Structural Issue (Pest harbourages)	At the time of inspection we observed aircurtain not worked					
		Access Issues	Nil					
		Description of Pest Infestation	It is Serious Threat for Beetles, lizards, flying insects and other crawling insects.					
		Any other observations	Nil					
		Preventive Action suggested to customer	Aircurtain should be working condition					
		Curative action from	We are instructed to Technician for Regular Monitoring.					
<p><b>Note: In General your all window mesh will be replaced all windows. Also in Processing area. Fly Killer Machine will be placed to Fly Catcher Machines</b></p>								
<b>For Pest Control Experts</b> Authorized Signature. Name: SURESH KUMAR.V Designation: MANAGER Emp.Code: 002 Phone Number: 8248672110
