PEST CONTROL EXPERTS

Facility Name & Address: Kalis Sparkling Water Private Limited, , Sricity	Audited On: 20-08-2025
Audited By: MOHAMMED YOUNUS.A	
Client Contact Person Name: Ms.Shobana	PC Experts Contact Person Name: MOHAMMED YOUNUS.A
Client Contact Person No: 7680875163	PC Experts Contact Person No: 9087200011

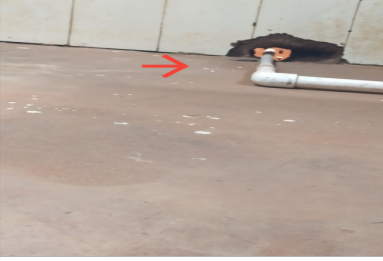
Location	Stamp Mold Area	23-09-2025	15-10-2025
		Cleaning / sanitation & Housekeeping Issues	Nil		
		Structural Issue (Pest harbourages)	Around the pipeline gap noticed.		
		Access Issues	Nil		
		Description of Pest Infestation	It is serious threat for rodent lizard & crawling insects		
		Any other observations	Nil		
		Preventive Action suggested to customer	Around the Pipeline Gap will be closed with cement mortar or Foam Sealant.		
		Curative action from	We are instructed to Technician for Regular Monitoring.

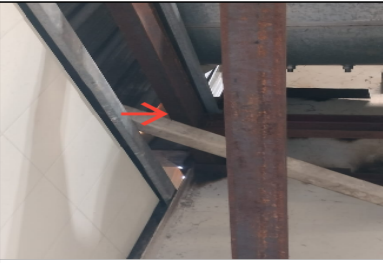
2

Location	Stamp Molding Area	17-09-2025	15-10-2025
		Cleaning / sanitation & Housekeeping Issues	Nil		
		Structural Issue (Pest harbourages)	Gap noticed between channel and sheet		
		Access Issues	Nil		
		Description of Pest Infestation	It is Serious Threats for Flies, Lizards & Aphids		
		Any other observations	Nil		
		Preventive Action suggested to customer	Around the channel Gap will be closed with cement mortar or Foam Sealant.		
		Curative action from	We are instructed to Technician for Regular Monitoring.		
3

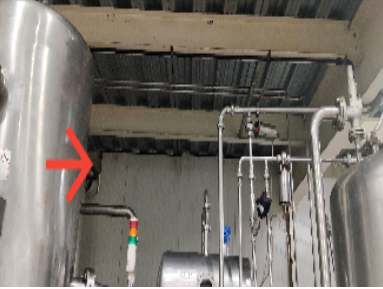
Location	Filler Area	16-09-2025	15-10-2025
		Cleaning / sanitation & Housekeeping Issues	Nil		
		Structural Issue (Pest harbourages)	Gap observed Roof Sheet Covings		
		Access Issues	Nil		
		Description of Pest Infestation	It is a serious threat for Flying insects, lizards and spiders		
		Any other observations	Nil		
		Preventive Action suggested to customer	Around the sheet Gap will be closed with cement mortar or Foam Sealant.

Curative action from	We are instructed to Technician for Regular Monitoring.		
4
