PEST CONTROL EXPERTS

Facility Name & Address: M/s. Kalis Sparkling Water Private Limited , Sricity	Audited On: 18-08-2025
Audited By: MOHAMMED YOUNUS.A	
Client Contact Person Name: Ms.Shobana	PC Experts Contact Person Name: MOHAMMED YOUNUS.A
Client Contact Person No: 7680875163	PC Experts Contact Person No: 9087200011

FACILITY SURROUNDING

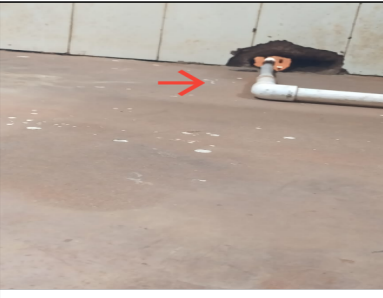
2

Location	Stamp mould area	22-09-2025	15-10-2025
		Cleaning / sanitation & Housekeeping Issues	Nil		
		Structural Issue (Pest harbourages)	Around the pipeline gap noticed.		
		Access Issues	Nil		
		Description of Pest Infestation	It is serious threat for rodents snakes flies lizards and crawling insects		
		Any other observations	Nil		
		Preventive Action suggested to customer	Around the Pipeline Gap will be closed with cement mortar or Foam Sealant.		
		Curative action from	We are instructed to Technician for Regular Monitoring.		
3

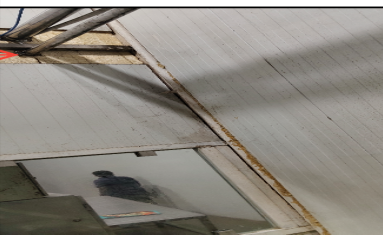
Location	Filling Area	22-09-2025	15-10-2025
		Cleaning / sanitation & Housekeeping Issues	Nil		
		Structural Issue (Pest harbourages)	Around the pipeline gap noticed		
		Access Issues	Nil		
		Description of Pest Infestation	It is Serious threats for flies spiders and lizards.		
		Any other observations	Nil		
		Preventive Action suggested to customer	Around the pipeline gap will be closed Sealant		
		Curative action from	We are instructed to Technician for Regular Monitoring.		
5

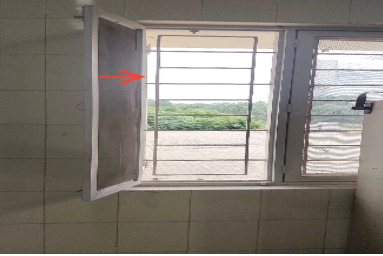
Location	PACKING AREA	22-09-2025	15-10-2025
		Cleaning / sanitation & Housekeeping Issues	Nil		
		Structural Issue (Pest harbourages)	Windows door kept open		
		Access Issues	Nil		
		Description of Pest Infestation	It is serious threat for flies lizards mosquitoes ants and Aphids.		
		Any other observations	Nil		
		Preventive Action suggested to customer	Doors kept closed condition.		
		Curative action from	We are instructed to Technician for Regular Monitoring.

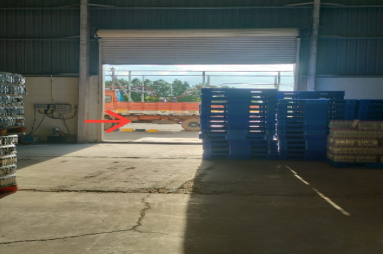
Location	FG Area	22-09-2025	15-10-2025
		Cleaning / sanitation & Housekeeping Issues	Nil		
		Structural Issue (Pest harbourages)	PVC strips/Air Curtains not available.		
		Access Issues	Nil		
		Description of Pest Infestation	The serious threat for rodents snakes lizards mosquitoes and Aphids		
		Any other observations	Nil		
		Preventive Action suggested to customer	Air Curtains / PVC strips must be placed		
		Curative action from	We are instructed to Technician for Regular Monitoring.		
9

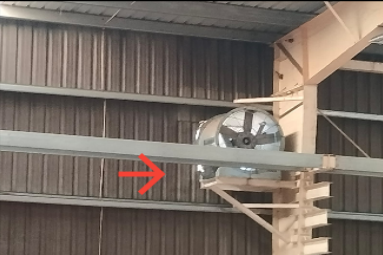
Location	Stamp mould area labelling area FG area packing area	22-09-2025	15-10-2025
		Cleaning / sanitation & Housekeeping Issues	Nil		
		Structural Issue (Pest harbourages)	Around the exhaust gap noticed		
		Access Issues	Nil		
		Description of Pest Infestation	It is serious threat for lizards and flies		
		Any other observations	Nil		
		Preventive Action suggested to customer	Around the exhaust gap will be closed with proper Sealant

Curative action from	We are instructed to Technician for Regular Monitoring.
