PEST CONTROL EXPERTS
No.6, 1st Floor, Balaji Lodge Complex,
NH 46 Service Road(Chennai to Bangalore Highway),
Vellore - 632 004.Tamilnadu. Email:care@pestcontrolexpert.in
Cell: 9087200011 ; 90872000022

Facility Name & Address: M/s. plastic omnium Auto Inergy Pvt Ltd , Lalapet, Ranipet	**Audited On: 25-08-2025**
Audited By: SURESH KUMAR.V	
Client Contact Person Name: Ms.Sudha (Asst HR)	**PC Experts Contact Person Name: SURESH KUMAR.V**
Client Contact Person No: 9655249232	**PC Experts Contact Person No: 8248672110**

FACILITY SURROUNDING

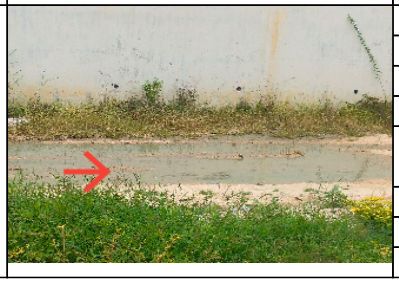
Location	Back side compound wall area		
		Cleaning / sanitation & Housekeeping Issues	Lot of water stagnated		
		Structural Issue (Pest harbourages)	Nil		
		Access Issues	Nil		
		Description of Pest Infestation	It is Serious Threat for mosquitos, other crawling insects		
		Any other observations	Nil		
		Preventive Action suggested to customer	Don't allow the stagnating water in factory premises

Curative action from	We are instructed to Technician for Regular Monitoring.
