PEST CONTROL EXPERTS

Facility Name & Address: CTR , ctr	Audited On: 22-09-2025
Audited By: SURESH KUMAR.V	
Client Contact Person Name: Suresh	PC Experts Contact Person Name: SURESH KUMAR.V
Client Contact Person No: 8248672110	PC Experts Contact Person No: 8248672110

FACILITY SURROUNDING

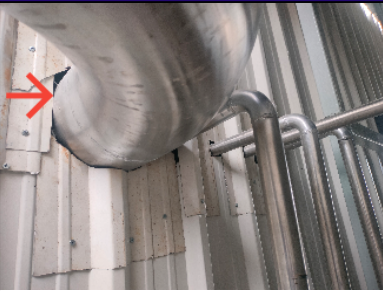
1

Location	AHU outer area		
	Cleaning / sanitation & Housekeeping Issues	Nil		
	Structural Issue (Pest harbourages)	From surrounding pipe line to metal sheet gap observed		
	Access Issues	Nil		
	Description of Pest Infestation	It is Serious Threat for Ants, beetle, lizards, flying insects and other crawling insects		
	Any other observations	Nil		
	Preventive Action suggested to customer	Gap should be closed form sealent		
	Curative action from	We are instructed to Technician for Regular Monitoring.

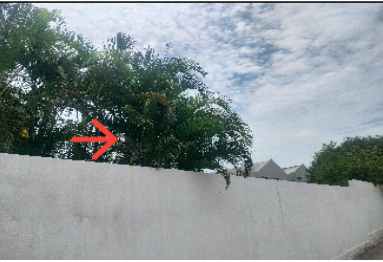
Location	Compound wall		
		Cleaning / sanitation & Housekeeping Issues	Tree branches fall down on the Wall		
		Structural Issue (Pest harbourages)	Nil		
		Access Issues	Nil		
		Description of Pest Infestation	It is Serious Threat for Ants, lizards and crawling insects		
		Any other observations	Nil		
		Preventive Action suggested to customer	Tree branches should be clean on regular basis		
		Curative action from	We are instructed to Technician for Regular Monitoring.
